**City of Pittsburgh  
2022-ITQB-203  
ITQB: Swimming Pool Assessment Study**

June 15, 2023

## Bloomfield Pool

### 3. Bloomfield Pool – 408 Ella St, Pittsburgh, PA 15224

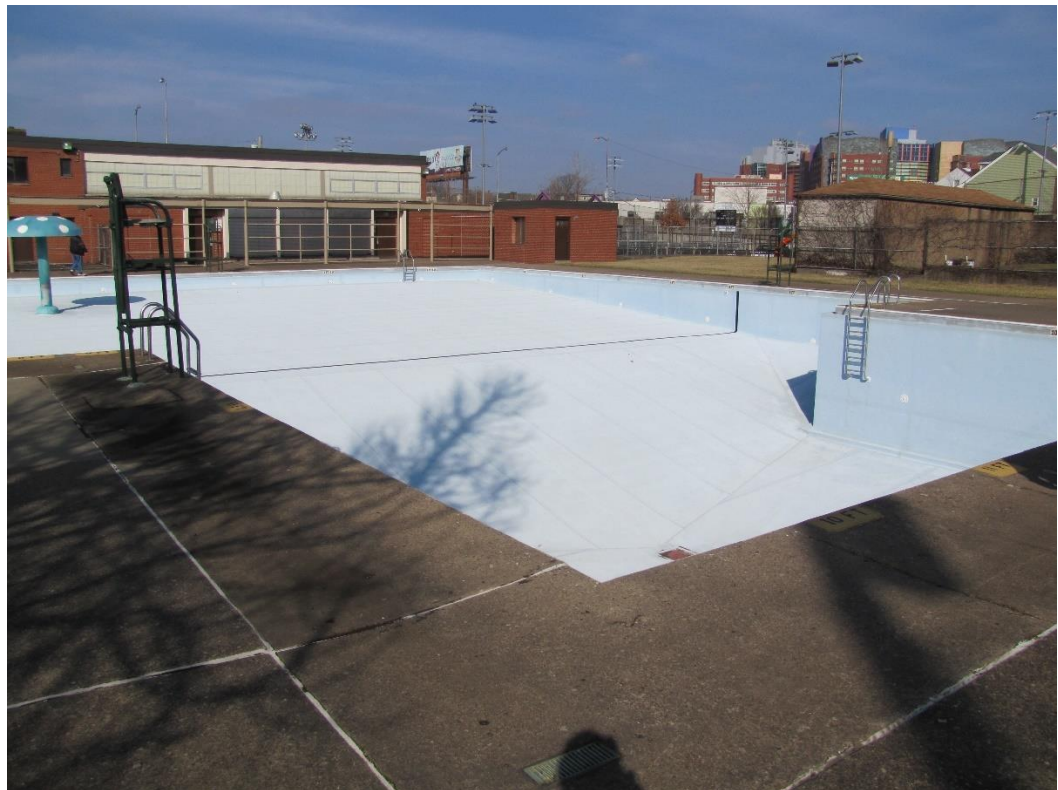
Figure 3.a-1

- Bloomfield Pool is a “T” configuration ranging in depth from 1 ½ ft to 12 ft.
- It is a “step in” design with a series of ladders for entry therefore being inherently non-ADA accessible in its base design.
- It is of concrete construction which is obscured by a vinyl liner.
- The recirculation system is comprised of:
  - a vinyl clad cast perimeter intake gutter with a cantilever deck design.
  - a direct link trench style main drain box with heavy steel grate (the drain piping size could not be confirmed)
  - a side wall return system for filtered water distribution.
- No play features or water play amenities exist.
- The pool has a vinyl liner.

The liner appears in good condition despite some minor wrinkling. No work is required at this time.

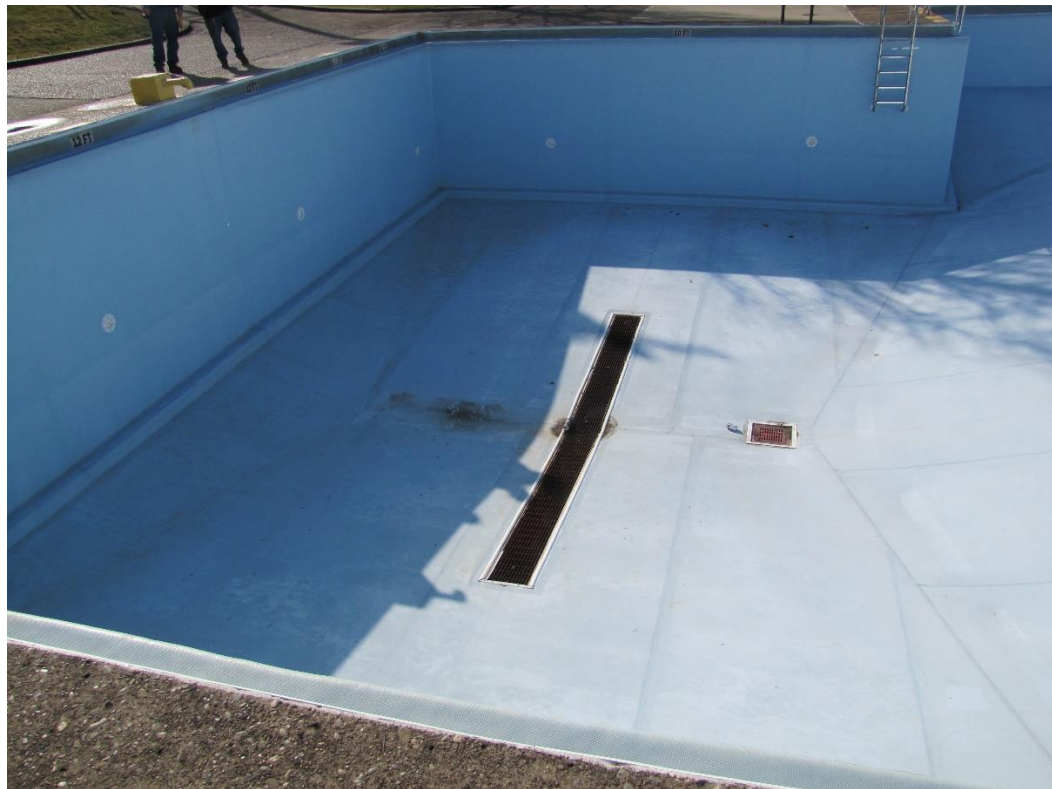
Figure 3.a-2

2. The main trench drain is direct linked to the filter system and is not VGB compliant. At a minimum a new grate is required, but likely a new sump.

Estimated cost: New sump and grate \$80,000

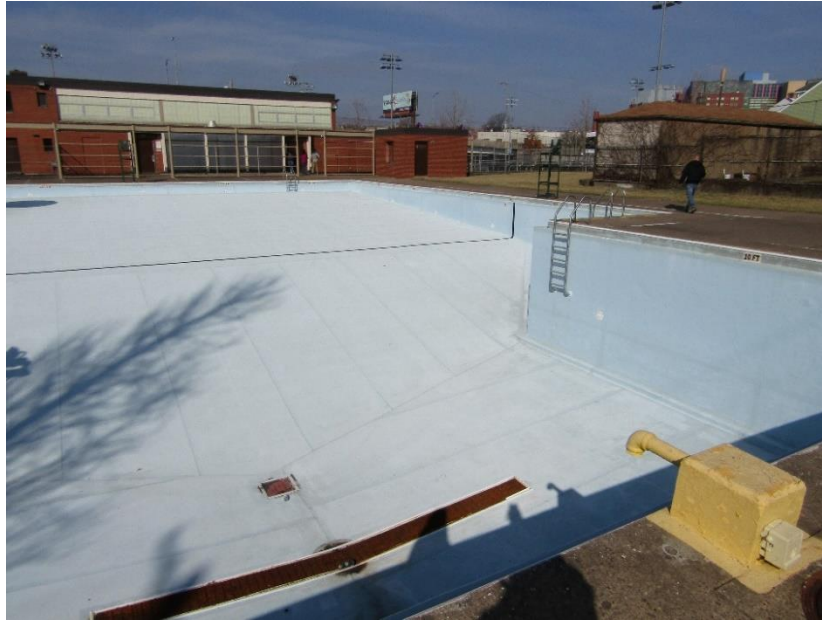
1. A large pool, such as this pool, is any pool that has more than three hundred (300) linear feet of pool wall and is required to have two (2) accessible means of access.
  - a. The primary access is to be via a sloped entry or a pool lift.
  - b. The second may be a Pool Lift, transfer wall, or accessible stairs.

The pool had two Handicap Accessible Pool Lifts on site.

**Figure 3.b-1: Pool access does meet current standards.**

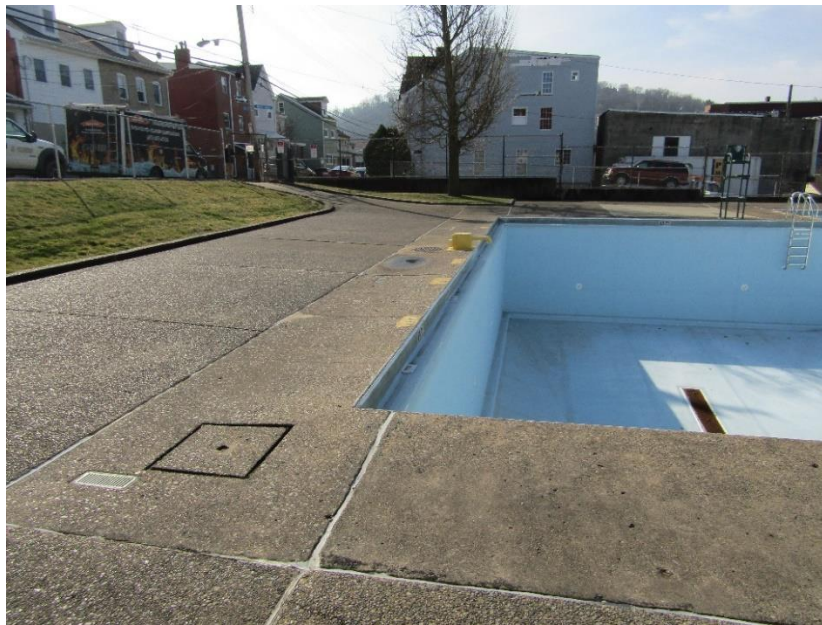
2. The pool deck contained areas of ponding water.

**Figure 3.b-2: Ponding water.**

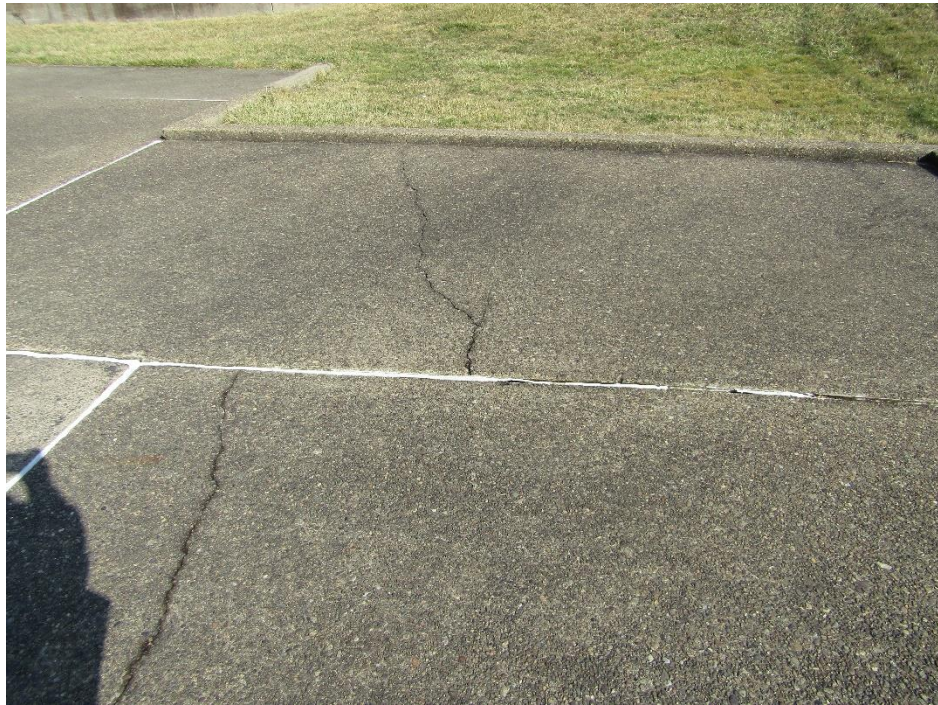
3. Numerous cracks located within the pool deck.

**Figure 3.b-3: Typical cracks.**

1. Pool deck replacement \$90,000 - \$110,000. The price may be able to be reduced with selective replacement. A survey will help us design and fine tune the areas needing replacement.
2. Pool deck cleaning is something the City staff can perform with a power washer and is not a safety issue, only an appearance issue.
3. Sidewalk and ramp repair. \$3,500 - \$4,500.
4. Parking lot restripe to create handicap parking stall. \$1,000-\$2000

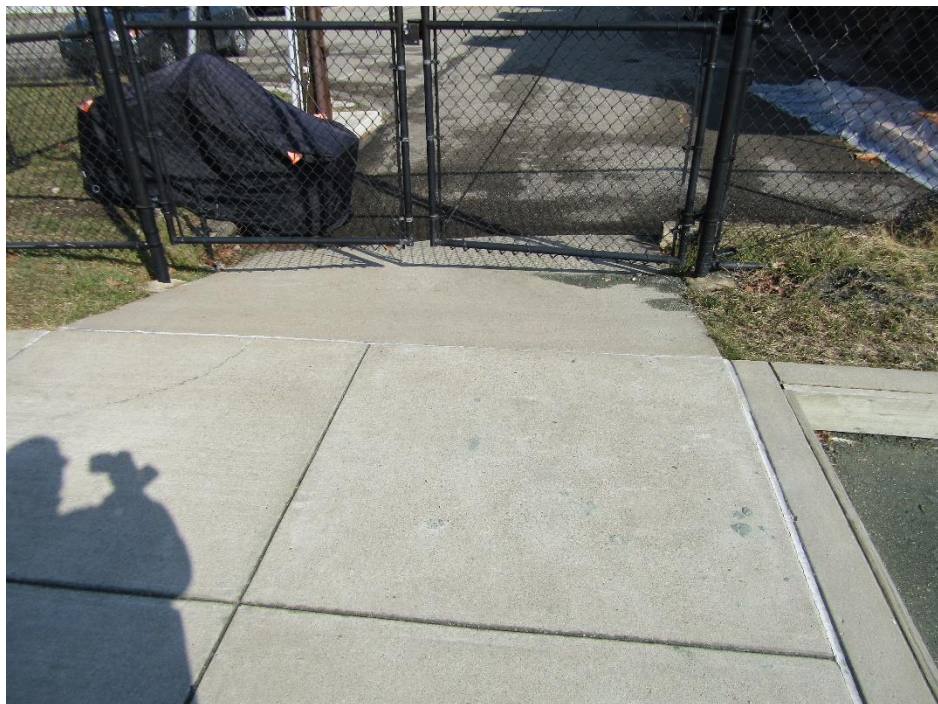
4. Ramp from parking lot does not meet code requirements.

**Figure 3.b-4: Ramp from parking lot.**

1. The critical site related items that would need to be addressed are all related to handicap accessibility and safety concerns.
  - a. Update the parking lot and ramps to meet current accessibility codes.
  - b. Reconstruct walkways and ramps to meet code and prevent tripping.

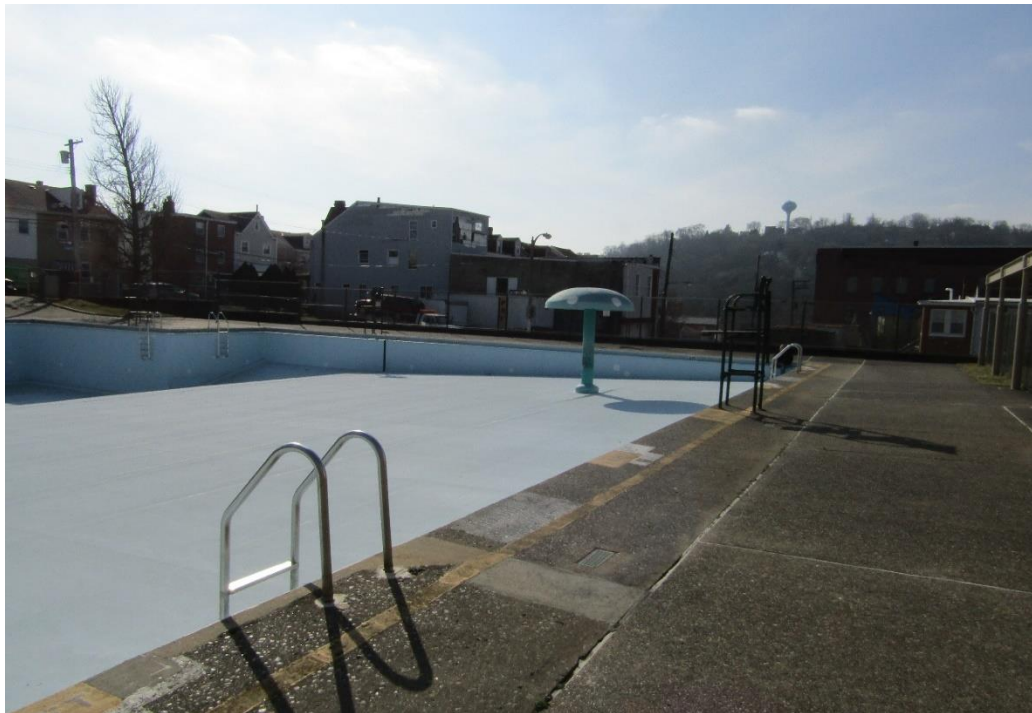
5. The pool deck is stained and needs cleaning.

**Figure 3.b-5: Pool deck discoloration indicates a need for cleaning.**

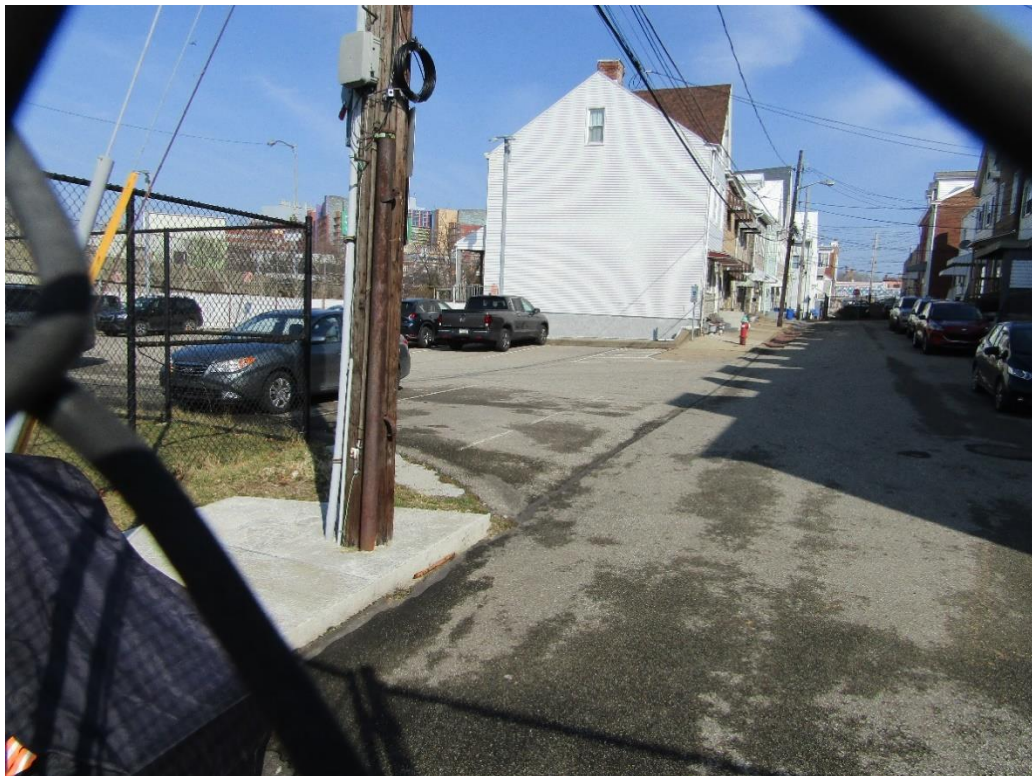
6. One handicap accessible parking stall is available in the shared parking lot. The stall does not meet code as it is not the closest to the pool entrance. There are no accessible spaces available on the street.

**Figure 3.b-6: Handicap parking stall in shared parking lot.**

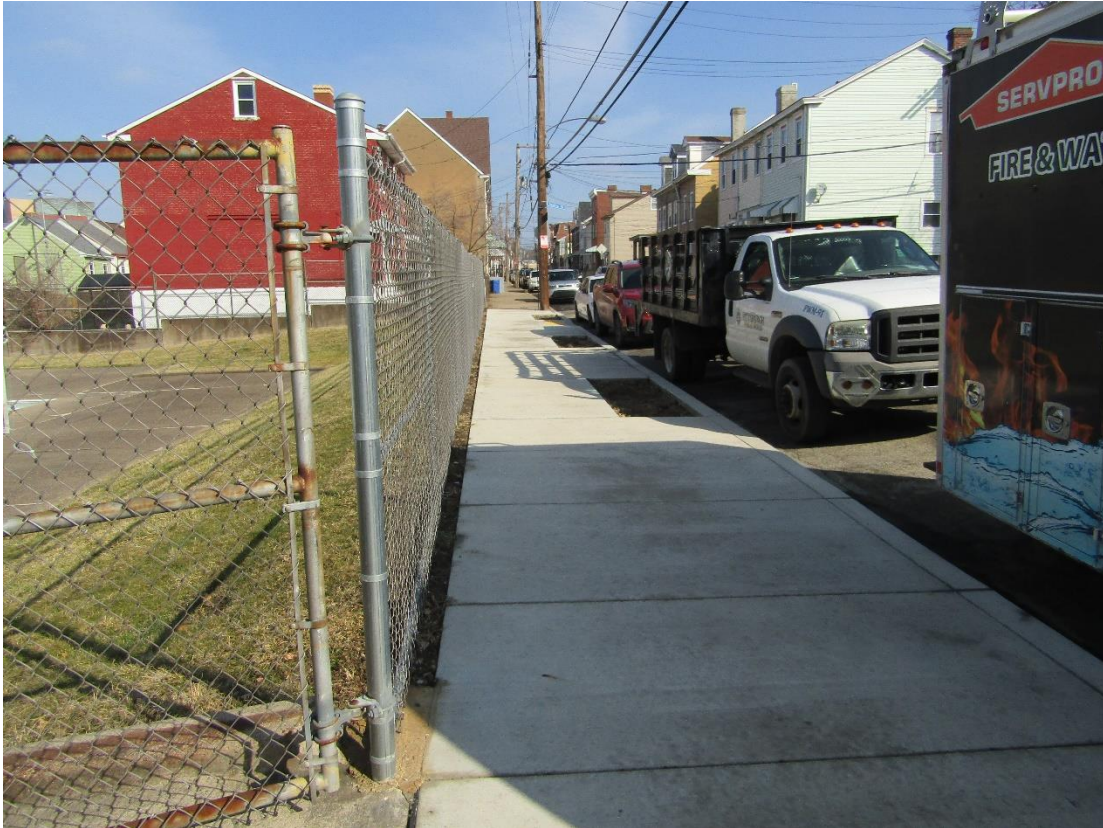
7. The fencing surrounding the pool appears to be in serviceable condition.

**Figure 3.b-7: Fencing is serviceable.**

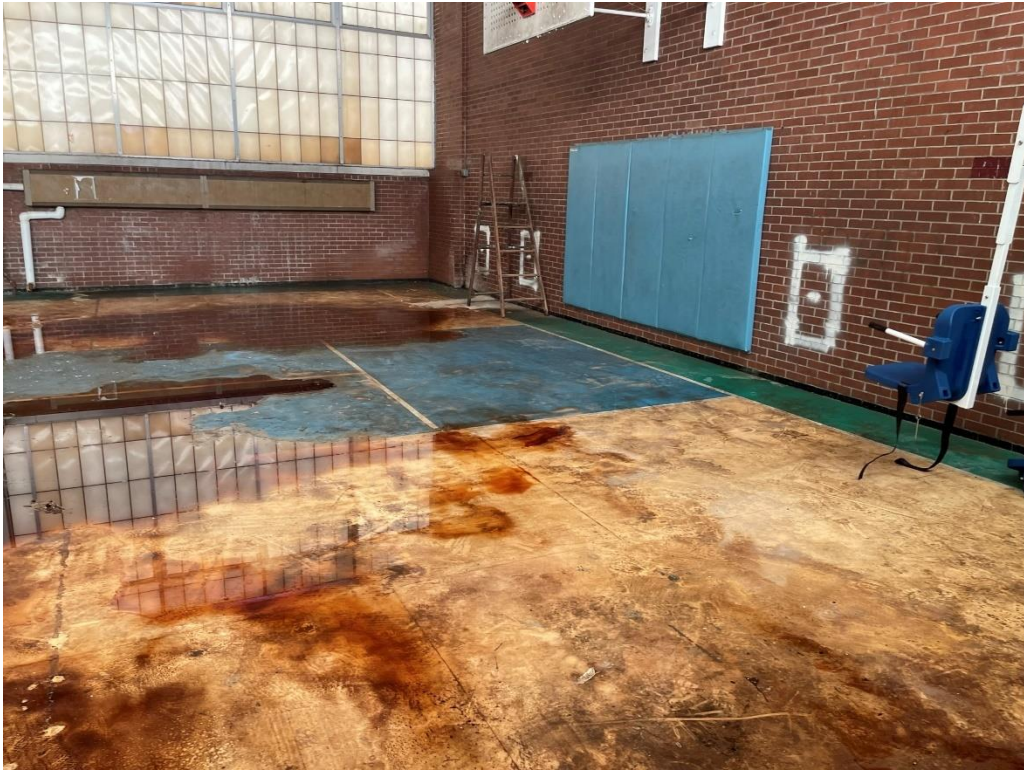
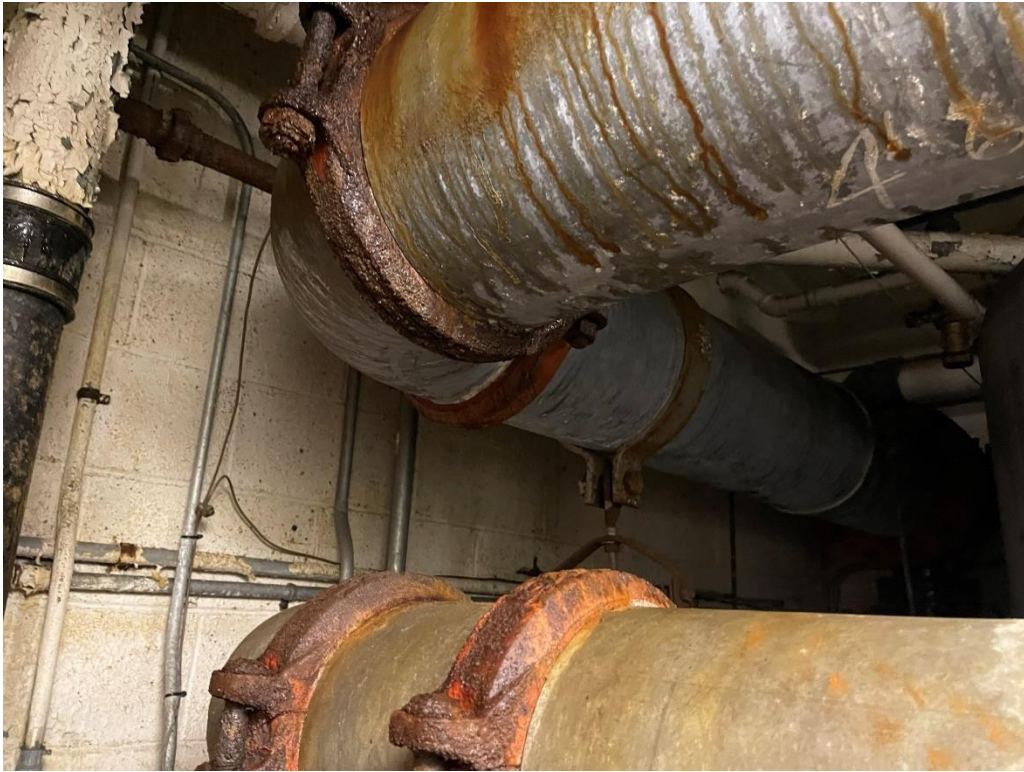
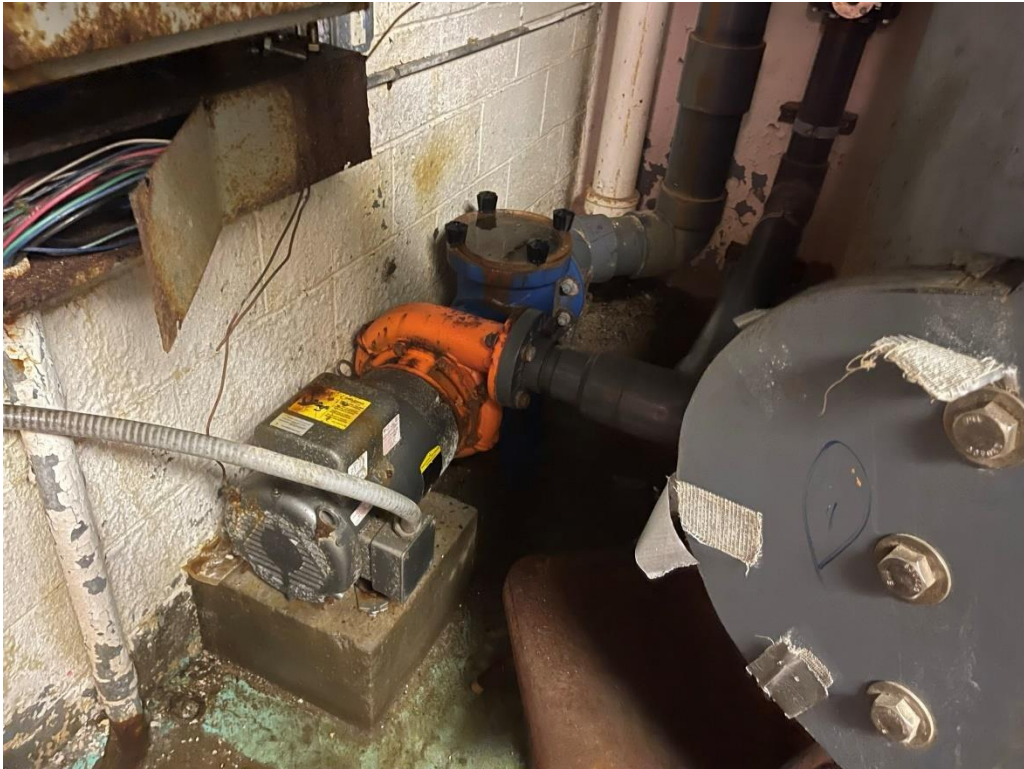
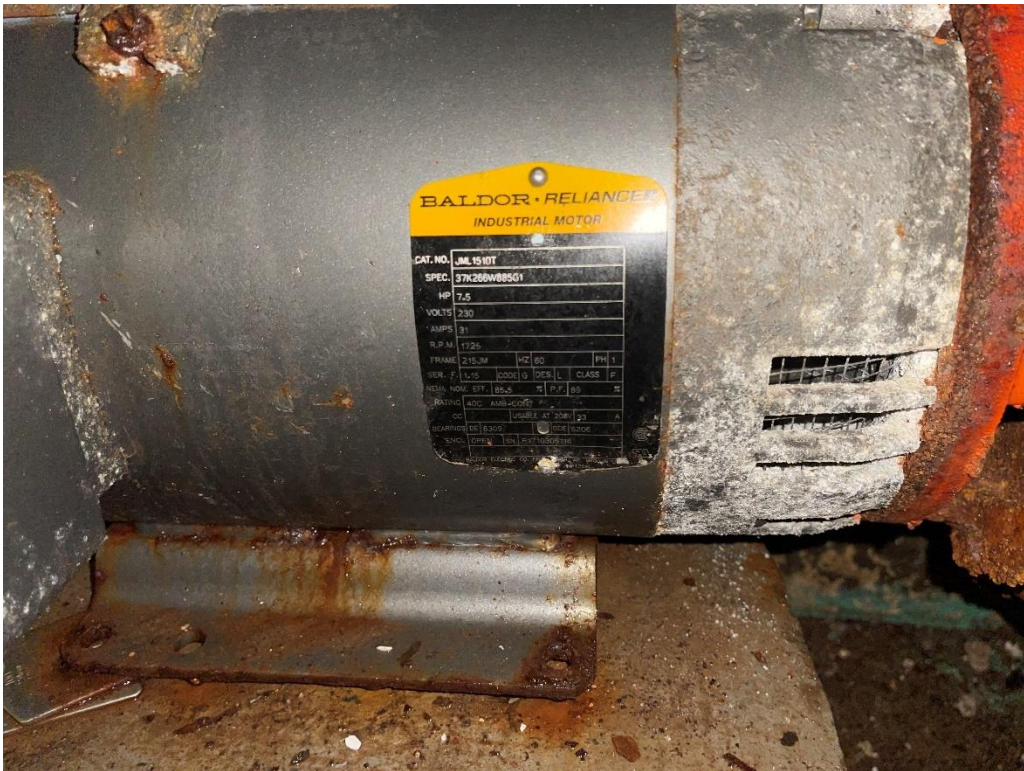
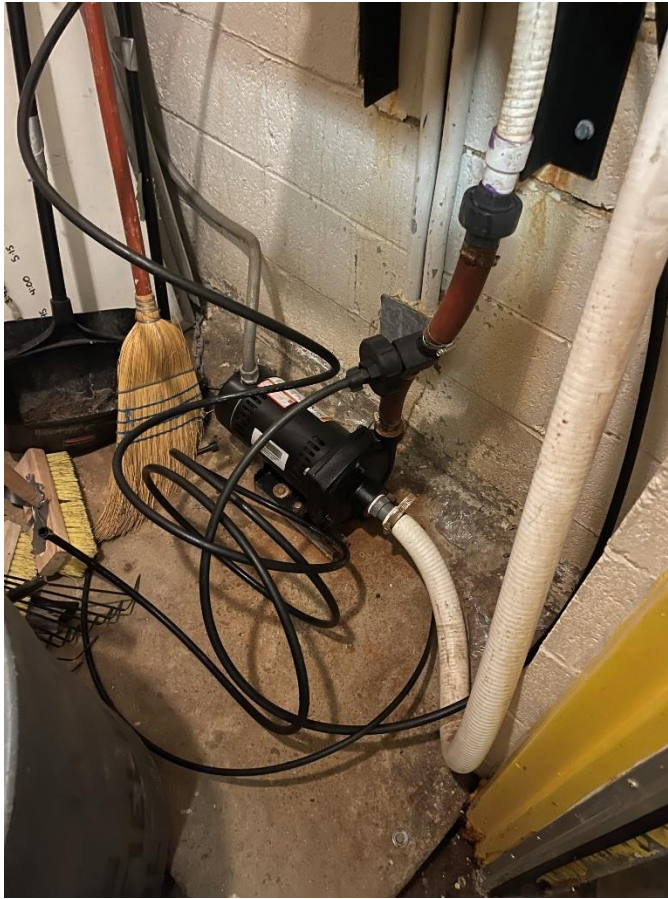
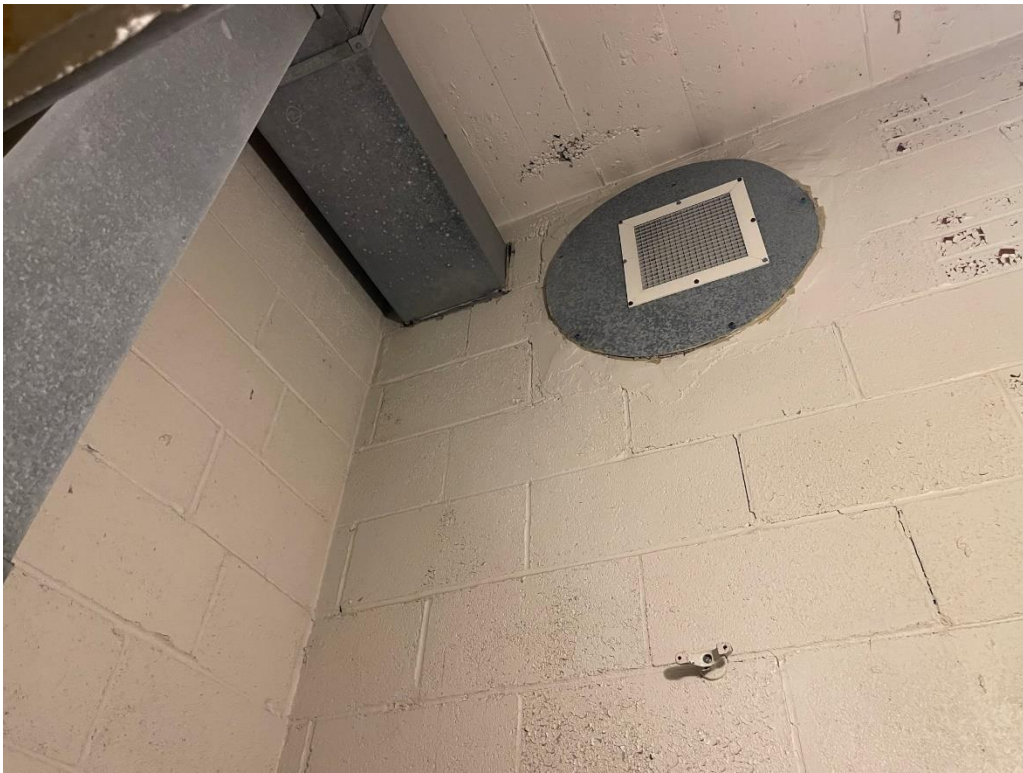
- i. Main Pump – Main pump needs to be replaced.
- ii. Chlorine Injection Pump – No issues to report.
- iii. Secondary “Mushroom” Pump – Needs to be replaced.
- iv. The incoming service pool fill line had no issues.
- v. The main drain size is 12”Ø with no issues reported.
  - a. The main drain is connected directly to the main pump.
- vi. There was no heat in the main pool filter room.
- vii. The main filter room is located the basement of an abandoned recreation center. The center itself is in bad condition with a significant number of leaks and water pooling on the first floor. The leaks are causing issues within the filter room.
- viii. The main shutoff valves need to be replaced due to corrosion and the conditions within the filter room. There are an estimated to be four 12”Ø valves that should be replaced.

The mechanical systems are in deteriorating condition due to the condition of the existing building and the water leaks throughout. The main pump and secondary “Mushroom” pump are required to be replaced but the building conditions need to be addressed before any new equipment is installed. Also, there are various pipes, fittings, and valves that may need to be replaced due to the ongoing water corrosion.

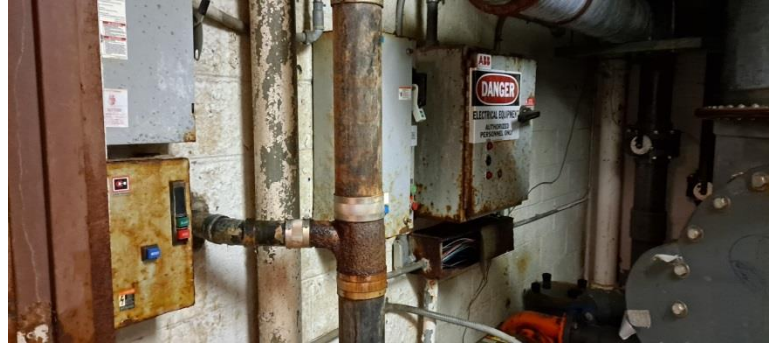
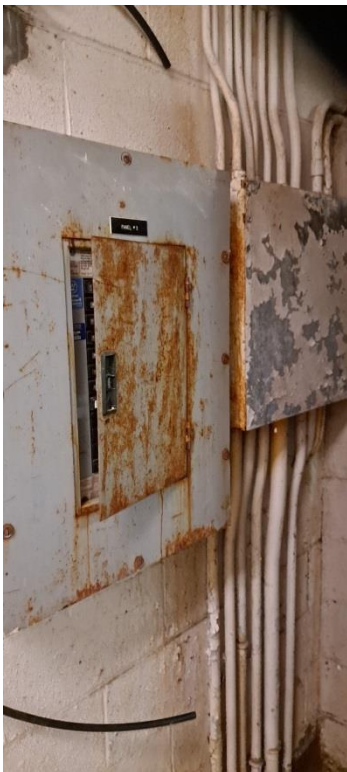
The electrical equipment at Bloomfield is in extremely deteriorated condition. Whether from dampness in the pool equipment room, or some other reason, all of the equipment is extremely rusted, both outer enclosure and interiors. All of the equipment needs to be replaced.

Pump control panel, wireway beneath and booster pump motor starter. All enclosures and equipment corroded and in unsafe condition for working.

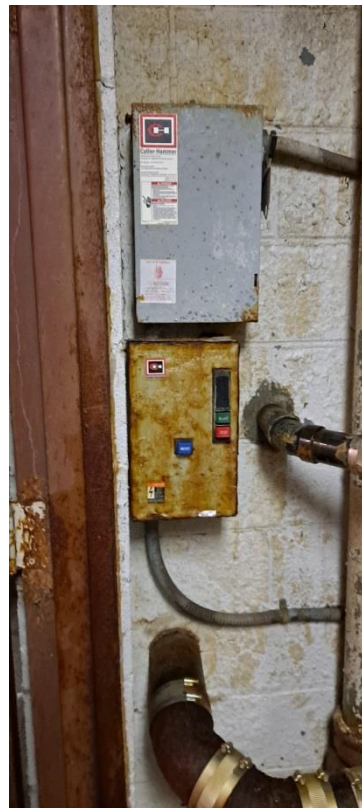
Distribution panelboard outside of pump room and equipment. Corrosion in this panel needs to be inspected for safety of this panel.

Booster pump motor starter and disconnect. Both in unsafe condition for operation.
