# Three Rivers Heritage Trail, Poor to Fair, High Risk

## Summary Report - Trails Surfaces

## SEGMENT: Monongahela North - Section 4, Segment 4

### Trail Surface, Asphalt Paving Assessment and Observations

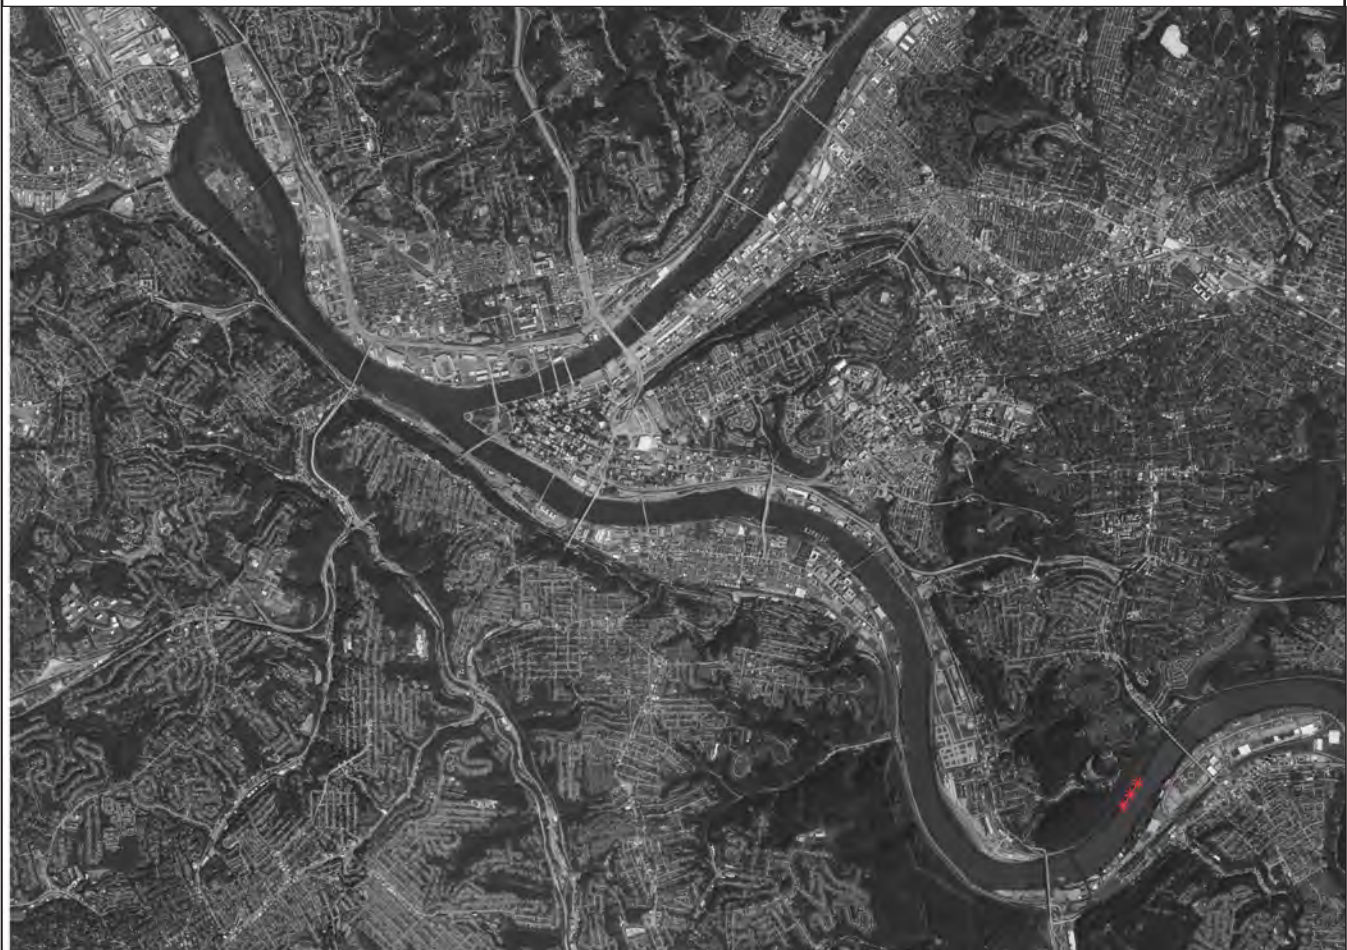
Trail segments categorized as Poor to Fair, High Risk tend to have worn or uneven surfaces that may show cracks, potholes, or drainage issues. Despite already suboptimal pavement or gravel conditions, the overarching concern here is geographic or structural risk factors—steep slopes, unstable soils, eroded embankments, failing retaining walls, or other hazards that jeopardize both the trail and user safety. Even though the surface condition by itself warrants repairs or resurfacing, the greater priority is mitigating the high-risk environment, which may include the potential for landslides or collapses. Because these risks could have costly or dangerous consequences, dedicated geotechnical or structural engineering inspections are strongly recommended. Those evaluations should identify immediate stabilization measures—such as reinforcing embankments, improving drainage, or repairing retaining walls—before any routine surface or aesthetic upgrades occur.

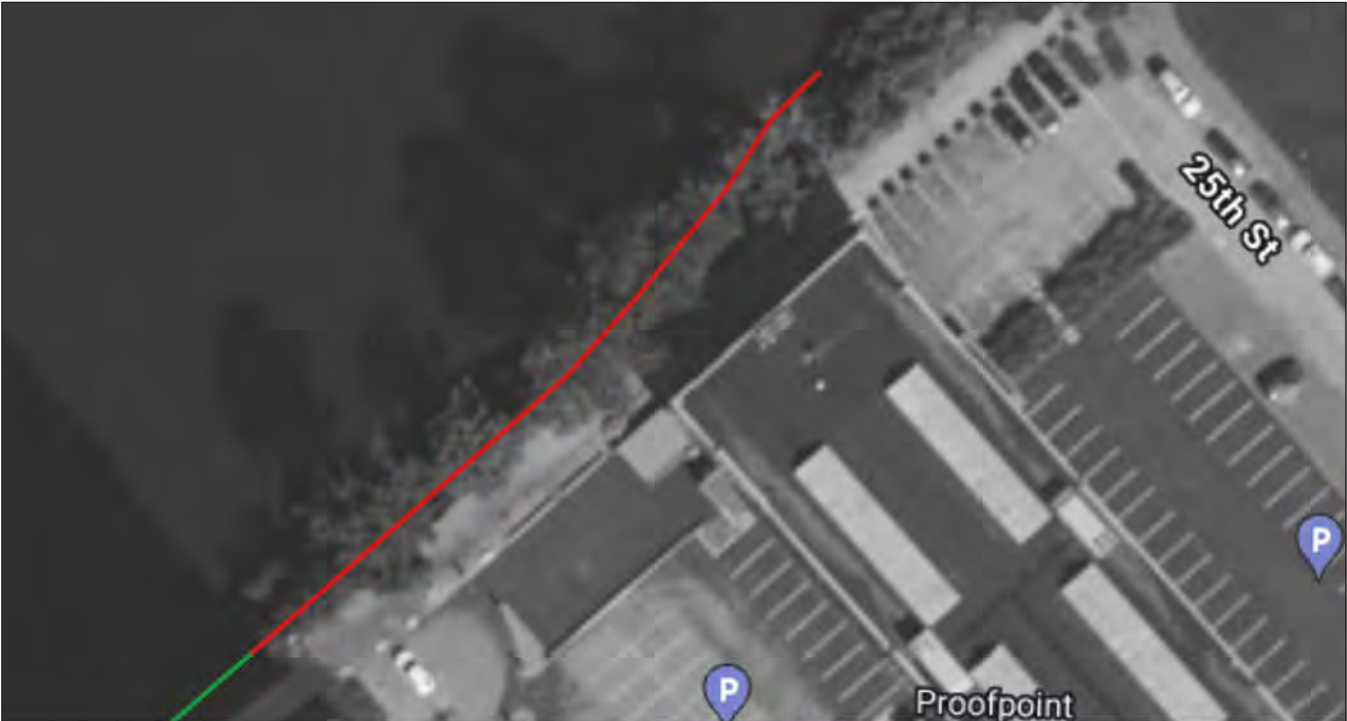
Assessment Rating: Fair to Good, High Risk

- Transverse cracks noted near the failing timber wall. Not certain if related to wall failure. Trail otherwise in good condition, but the timber wall presents a significant risk. Recommend reviewing DPW maintenance/repair records.

- Timber crib wall in 'Poor' condition per ACOE. Very aged timbers, failed horizontals, significant post deflection. Moderate to high risk given proximity and bank height.
- Another section of timber crib wall in 'Poor' condition per ACOE with similar issues—failed horizontals, deflected posts, moderate to high risk.

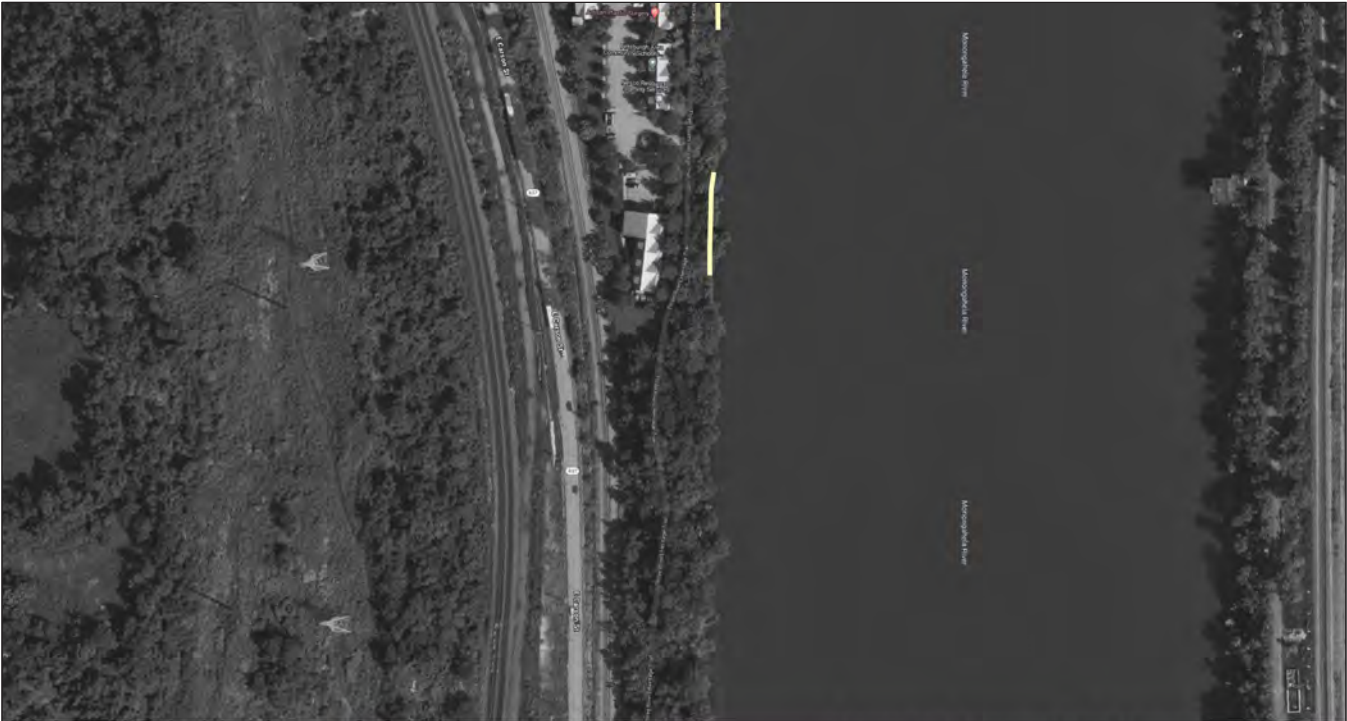
**Assessment Rating: Good to Excellent, High Risk**

- Large patched area (~90 sf).
- Minor watercourse crosses trail, causing muddy ponding and potential slip.
- High density of transverse/longitudinal cracks suggests accelerated service-life endpoint.

- Naturalized slopes in 'Fair' condition, but severe erosion undercutting trail support. High risk.

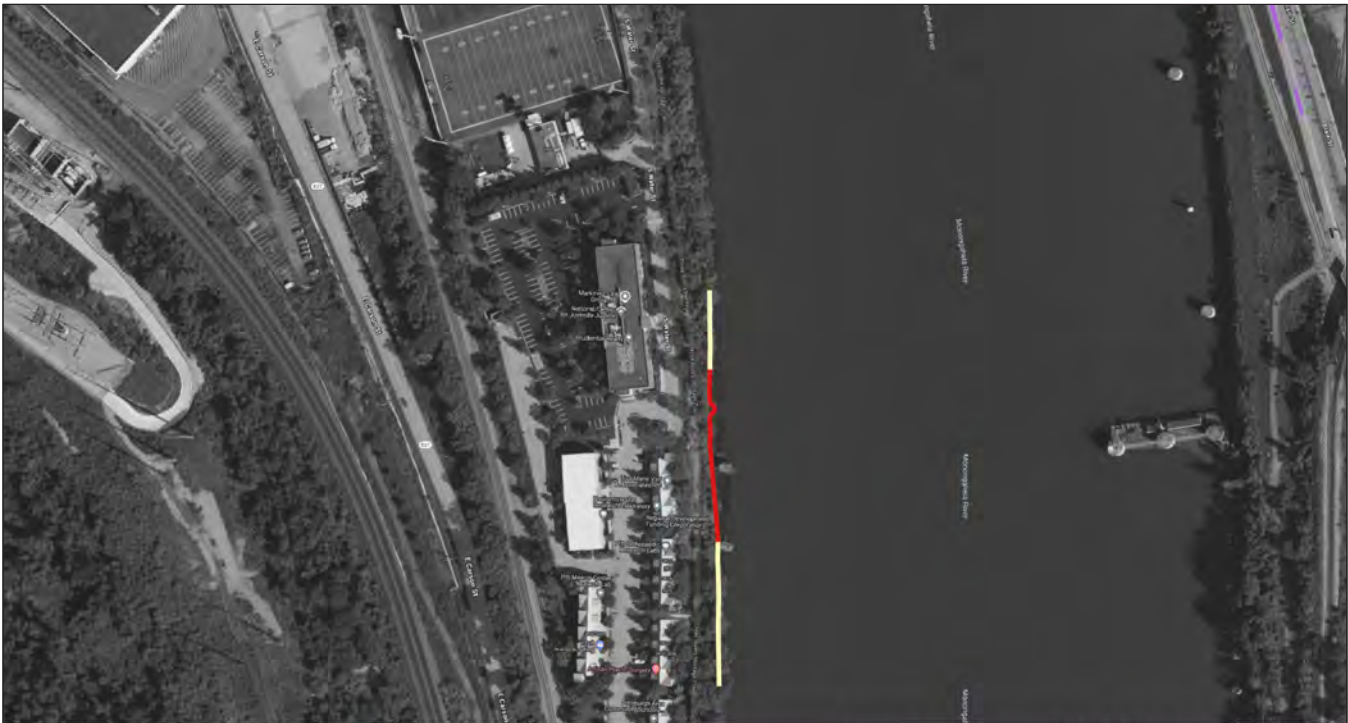
**Assessment Rating: Good to Excellent, High Risk**

- High density of transverse/longitudinal cracks suggests nearing service life.
- Large patched area (~75 sf).

- Walls of unknown composition in 'Poor' condition per ACOE (vertical/near-vertical). Severe undercut/failure. High risk due to proximity/height. ~1000 ft requires thorough evaluation.
- Steep, naturalized slopes rated 'Fair' but severe erosion undercutting trail support. High risk.
