# Three Rivers Heritage Trail, Poor to Fair, High Risk

## Summary Report - Trails Surfaces

## SEGMENT: Monongahela North - Section 4, Segment 4

### Trail Surface, Asphalt Paving Assessment and Observations

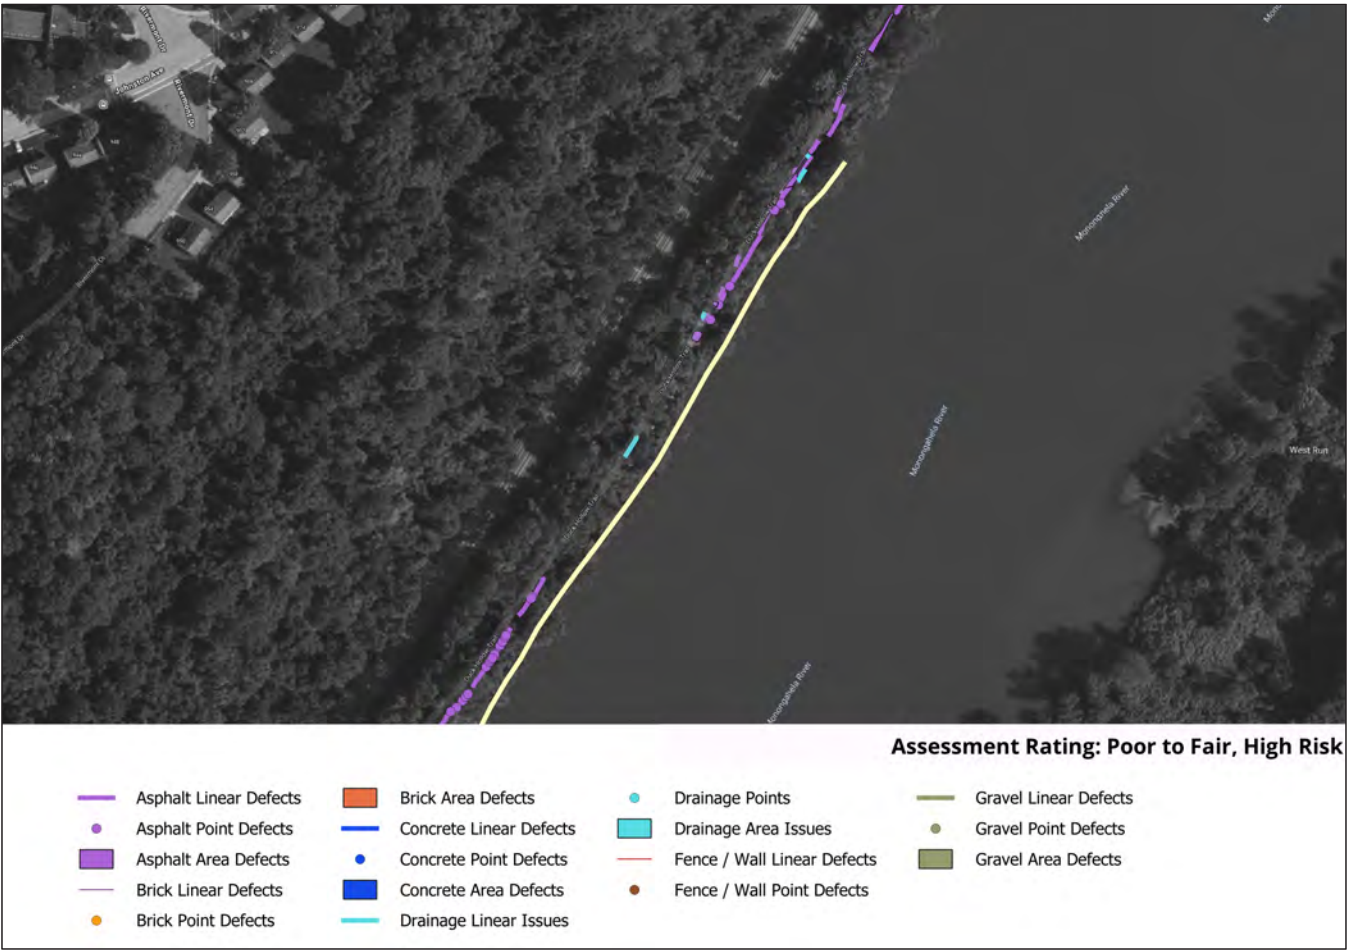
- Minor to moderate edge cracking along river-side edge (possible slippage).
- Numerous transverse cracks and some depressed ponding areas, mostly minor.
- Significant bridge crossing beneath the trail with historic ironworks. Surface is in good condition, but no structural assessment of the bridge itself was performed.

- About 15 ft of fence knocked down. Minor risk to pedestrians/bikers.
- Army Corp study indicates 'Fair' riprap stabilization adjacent to the trail. May relate to minor/moderate edge and longitudinal cracking. Recommend monitoring over time.

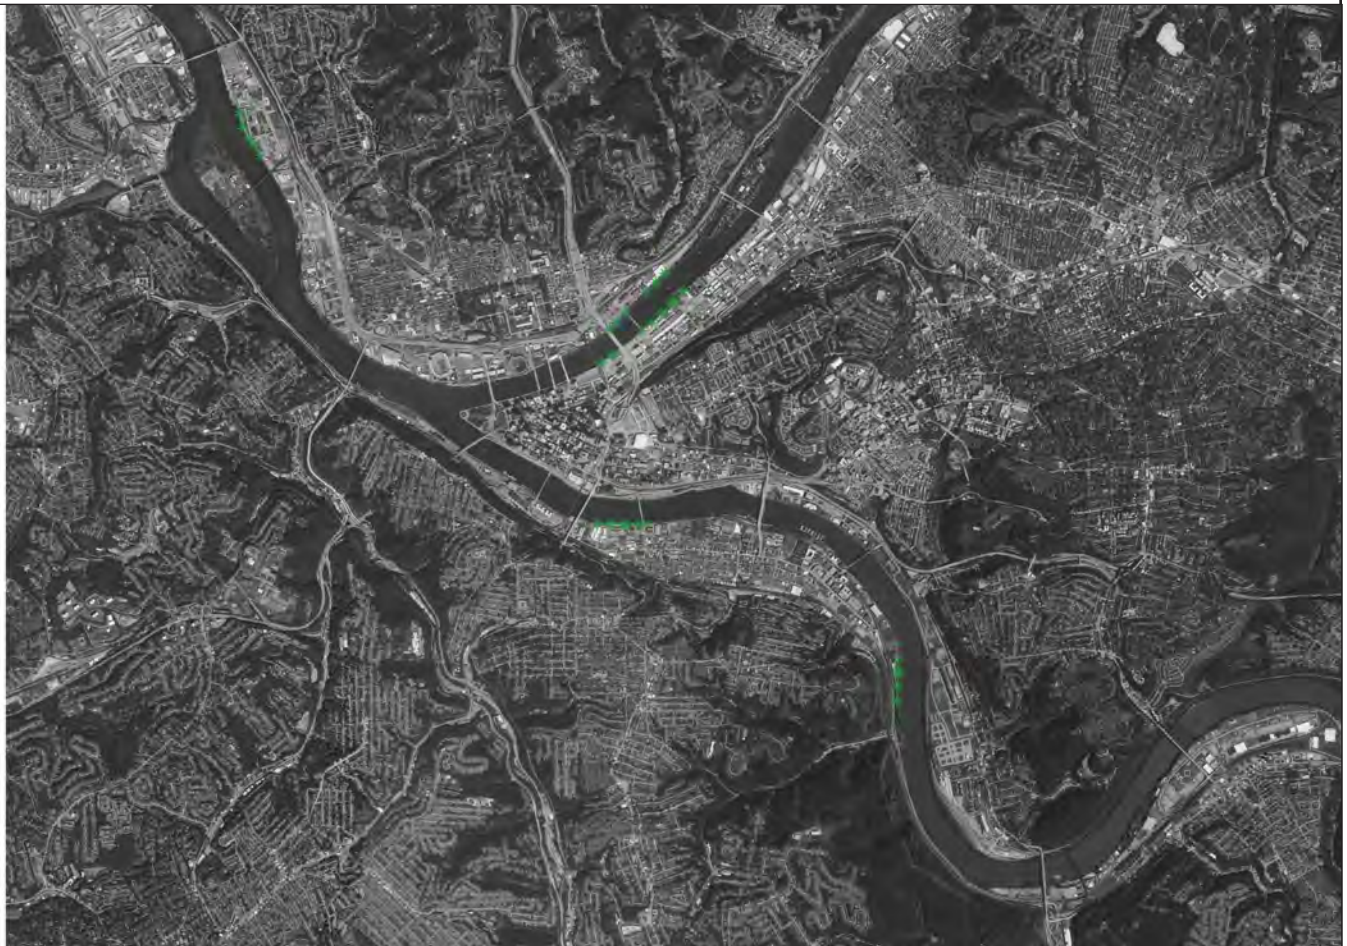
## SEGMENT: Ohio North - Section 1, Segment 2

- Edge cracking on the river side with flanking transverse cracks. Location corresponds to stream banks rated in 'Poor' condition from boat assessment.

- Undercut wharf wall, in 'Poor' condition per ACOE. Trail base consists of large precast block with asphalt poured on top. Undercutting is prevalent along base. Solutions may include armoring at base, or grouted backfill. Low to moderate risk.
- Naturalized, steep river banks in 'Fair' condition per ACOE. Some stones missing from vertical block wall, with undercutting at river edge. Low to moderate risk to trail.

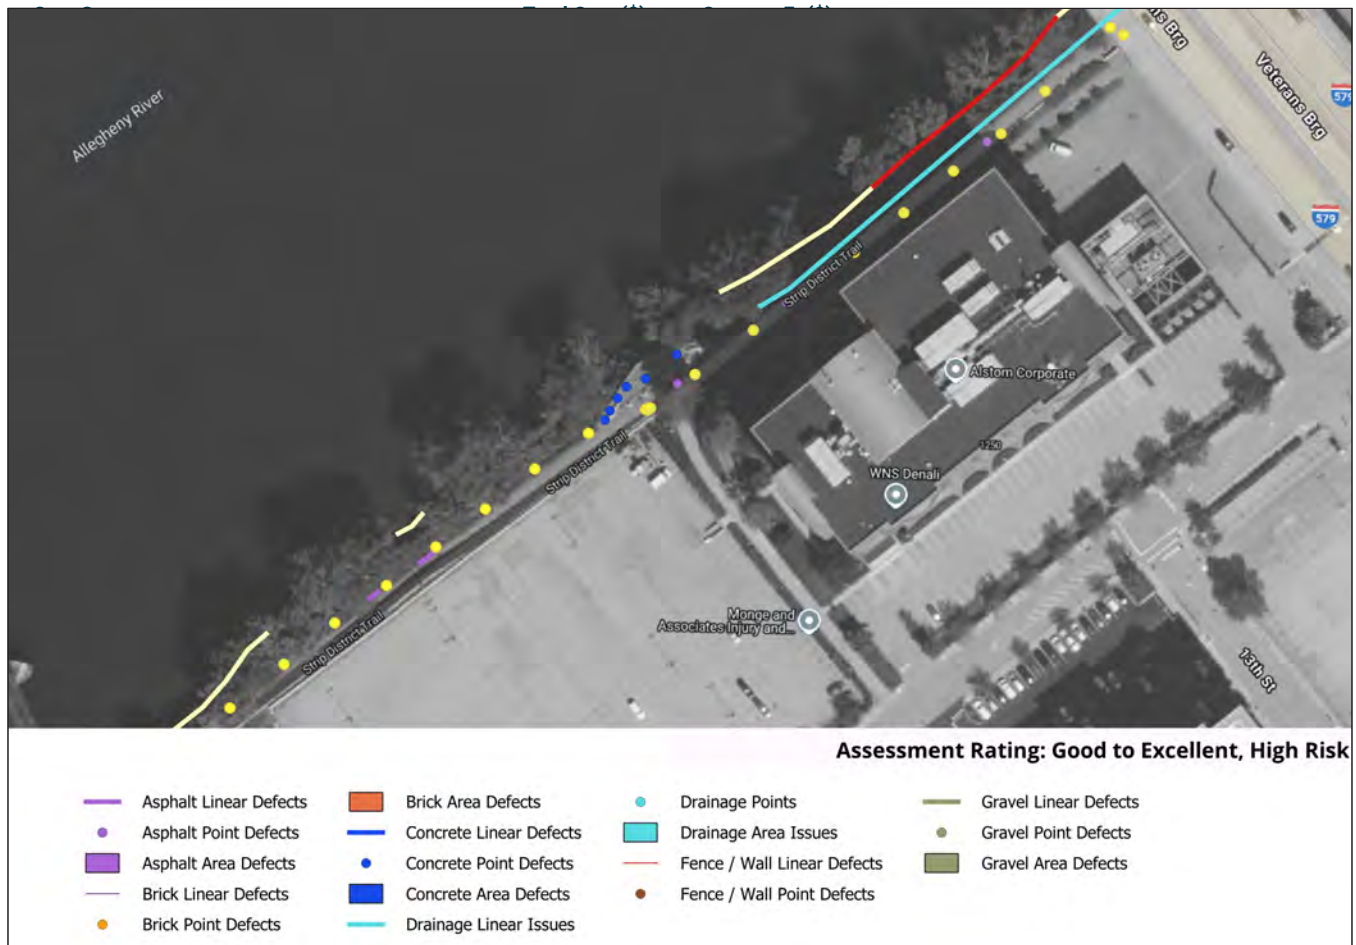
## SEGMENT: Allegheny North - Section 1, Segment 6

- Past depression and erosion point. DPW has attempted remediation with poured asphalt at the edge. Minor pedestrian hazard. Correlates with 'Poor' streambank conditions noted by ACOE/riverboat assessment.
- Extreme cross slope under the bridge, likely to mitigate erosion on the opposite side; minor pedestrian hazard.
- Minor edge cracking in areas.

- Banks under Veterans Bridge rated 'Poor' by ACOE. Severe, steep, bare earth erosion with undercut. Moderate risk to trail; recommend stabilization.
- Riprap banks rated 'Poor' by ACOE. Severely eroded with stone wall remnants. Moderate to high risk given proximity and height. Recommend bank stabilization or walls.
- Riprap banks in 'Fair' condition by ACOE. Large boulders and brush provide stable bank. Unsightly but stable. No recommendations.
- Portion of streambank east of the 'Poor' area is 'Fair' by ACOE; large boulders and brush. Unsightly but stable. No recommendations.

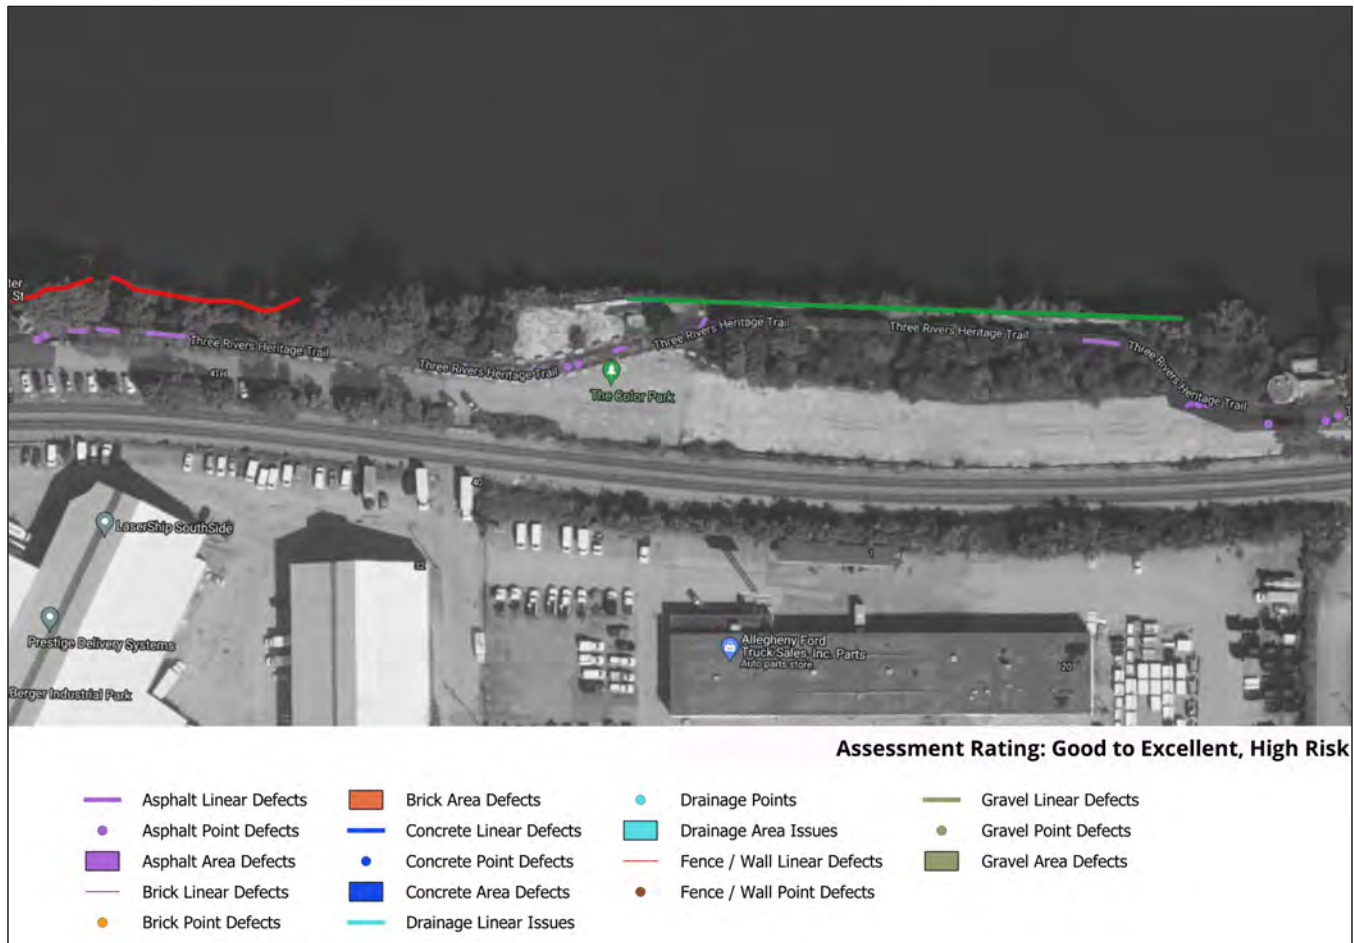
## SEGMENT: Monongahela South - Section 2, Segment 2

- Numerous transverse/longitudinal cracks and edge cracking, especially near walls rated 'Poor' (cause-effect unclear).
- Extensive spray painting on surface, beyond Color Park limits.

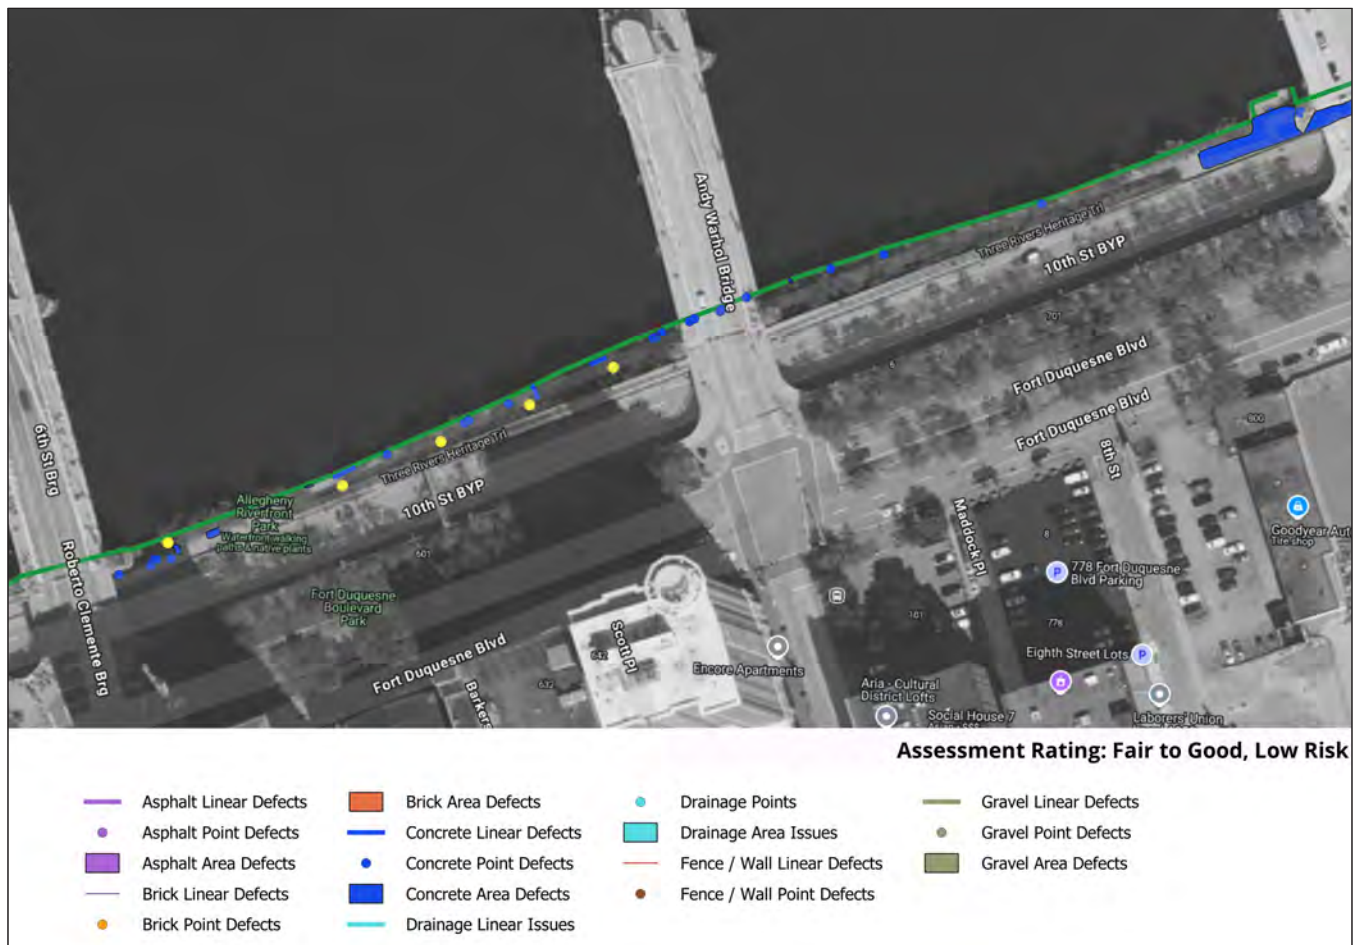
- Badly broken/cracked concrete slabs near existing street inlet (~20 ft). Recommend replacement.
- Corner-cracked slabs, transverse cracks, broken curbs, popouts in various spots.

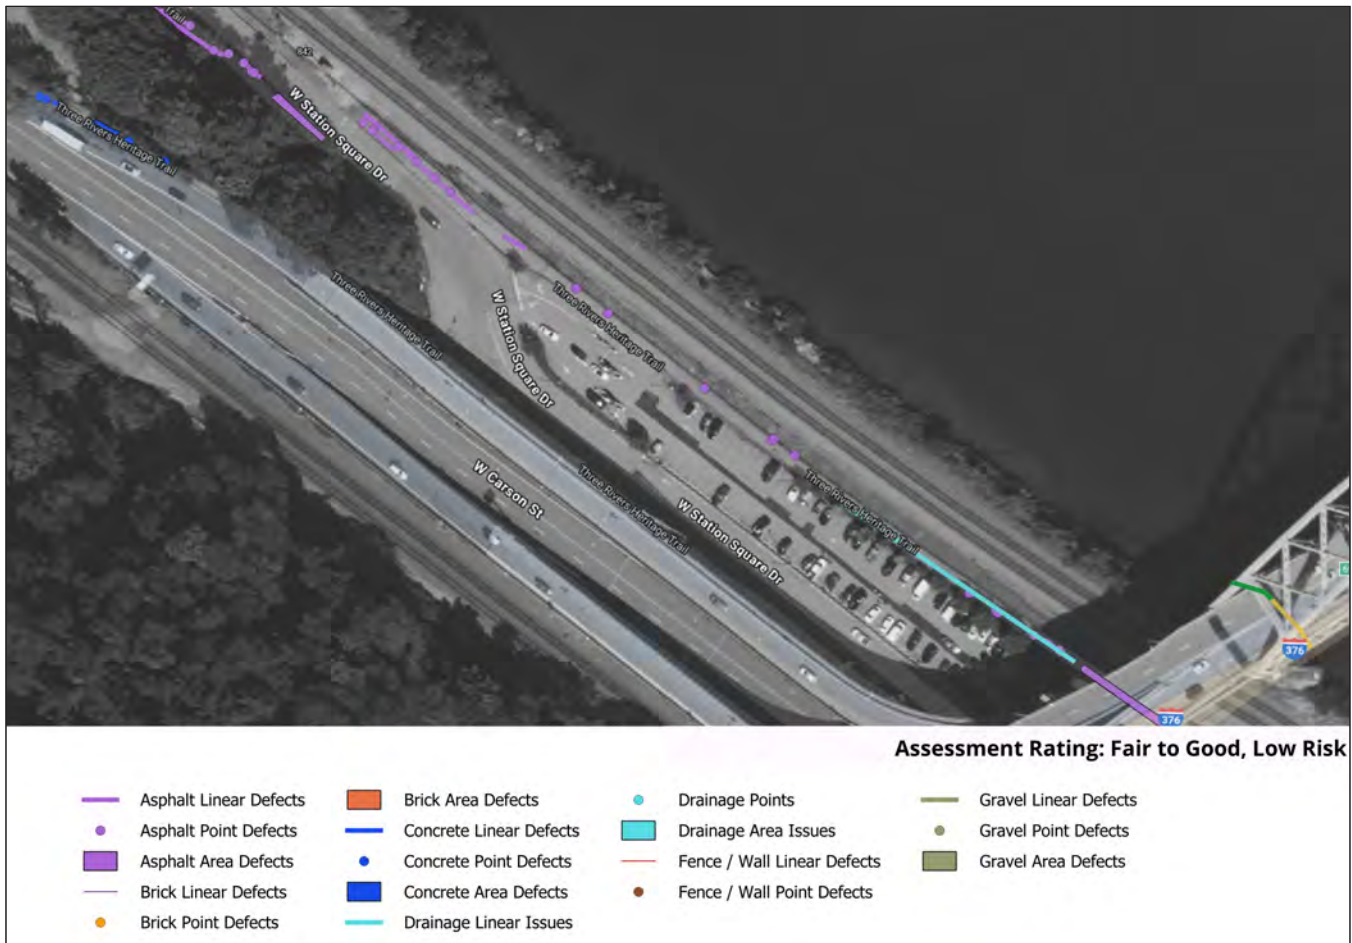
- Mulch washup from adjacent planter bed across large stretches of trail.
- Patching (~10 sf).
- Patching (~25 sf).
- Numerous transverse/longitudinal cracks, edge cracking, and depressions, especially where pavement overhangs railroad drainage on the opposite fence side.

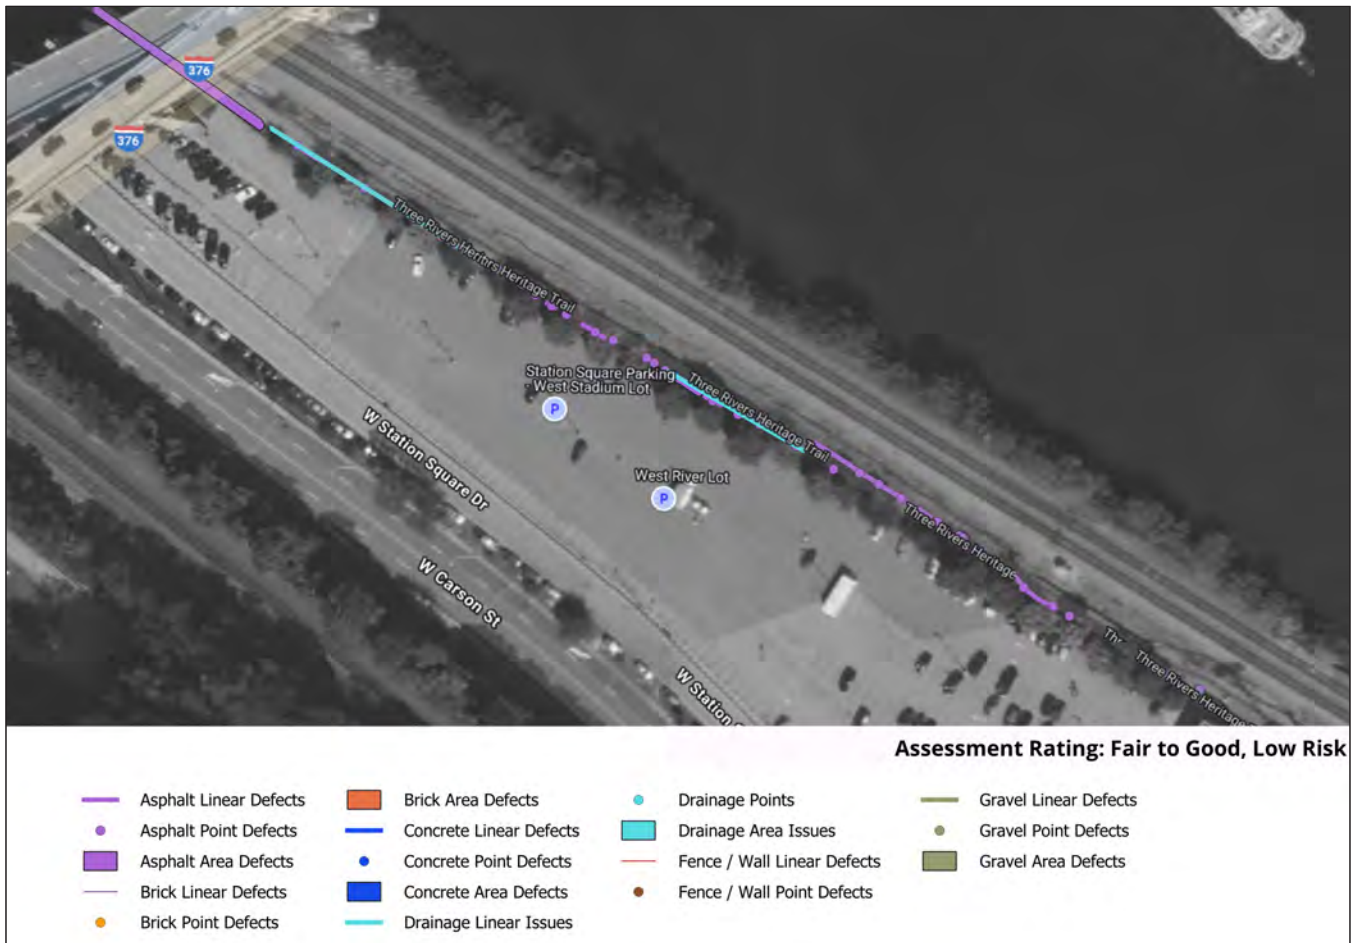
- Patching (~30 sf).
- Patching (~100 sf).
- Cracked/missing bricks, sunken areas, edge loss. Widespread but more severe in certain spots. Some bricks fully missing.
- Large area (~60 sf) of alligator cracking, potholes, low point with ponding.
- Numerous transverse/longitudinal cracks, edge cracking.
- Fence damage: hole in fence.

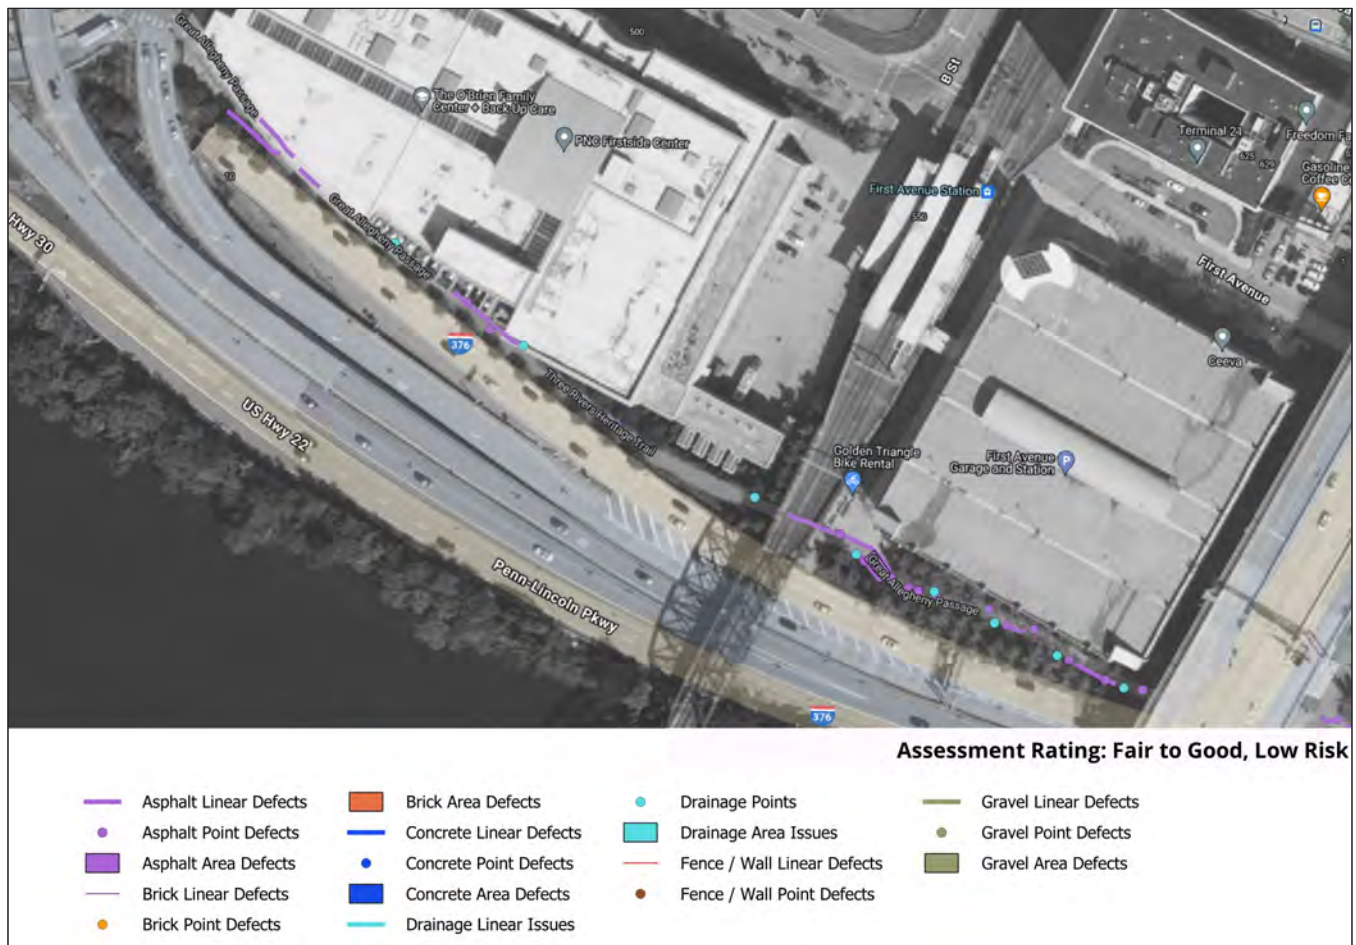
- Alligator cracking and sunken transition (~32 sf) between older pavement and newer adjacent pavement.
- Numerous transverse/longitudinal cracks, potholes, and depressions. Mostly minor to moderate, but frequency is high, indicating end of service life.

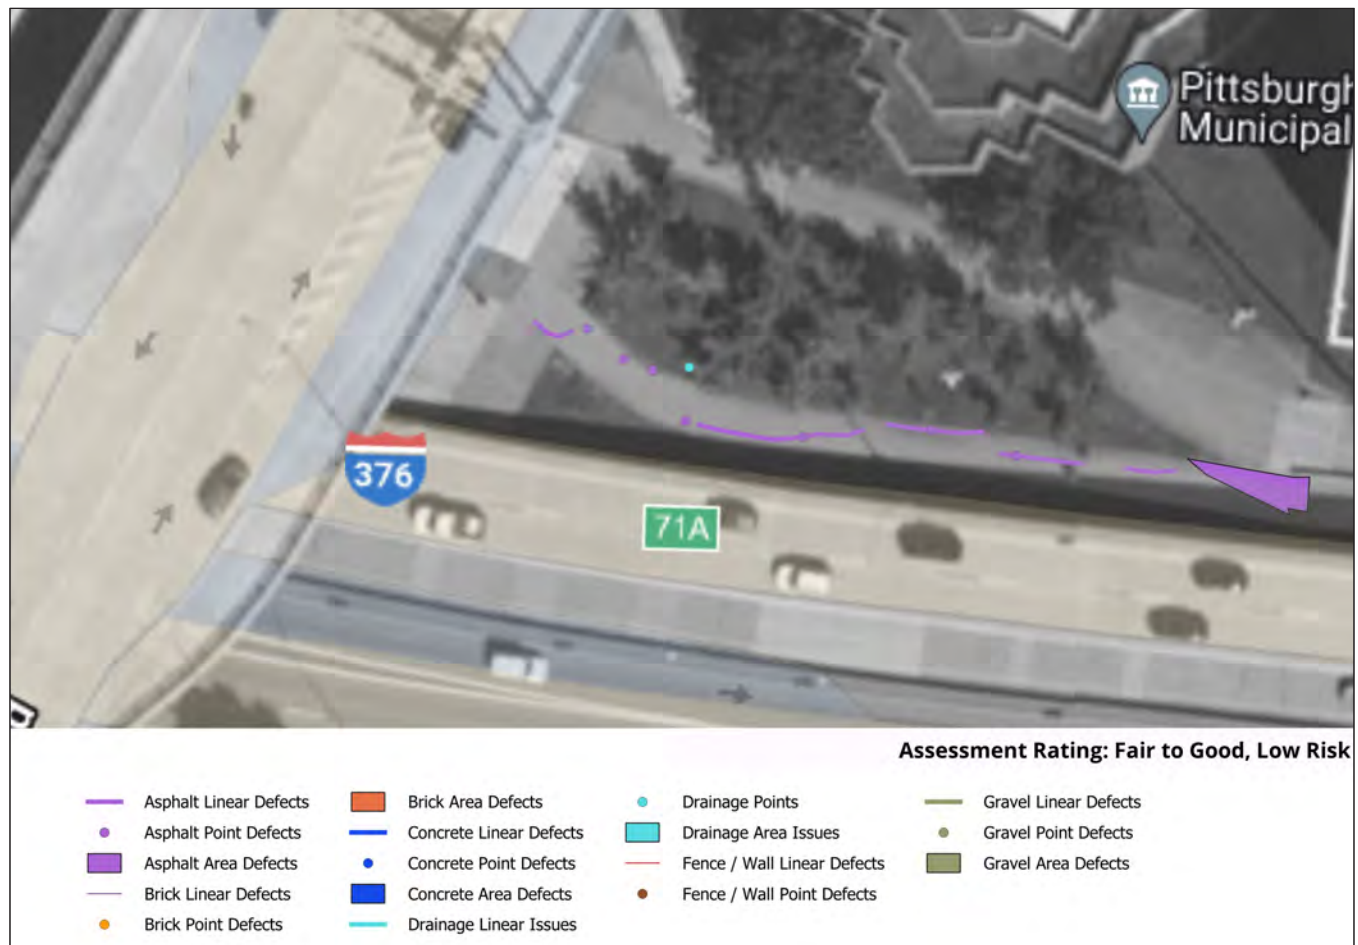
- Numerous transverse/longitudinal cracks, potholes, and depressions. Mostly minor to moderate, but frequency is high, indicating end of service life.

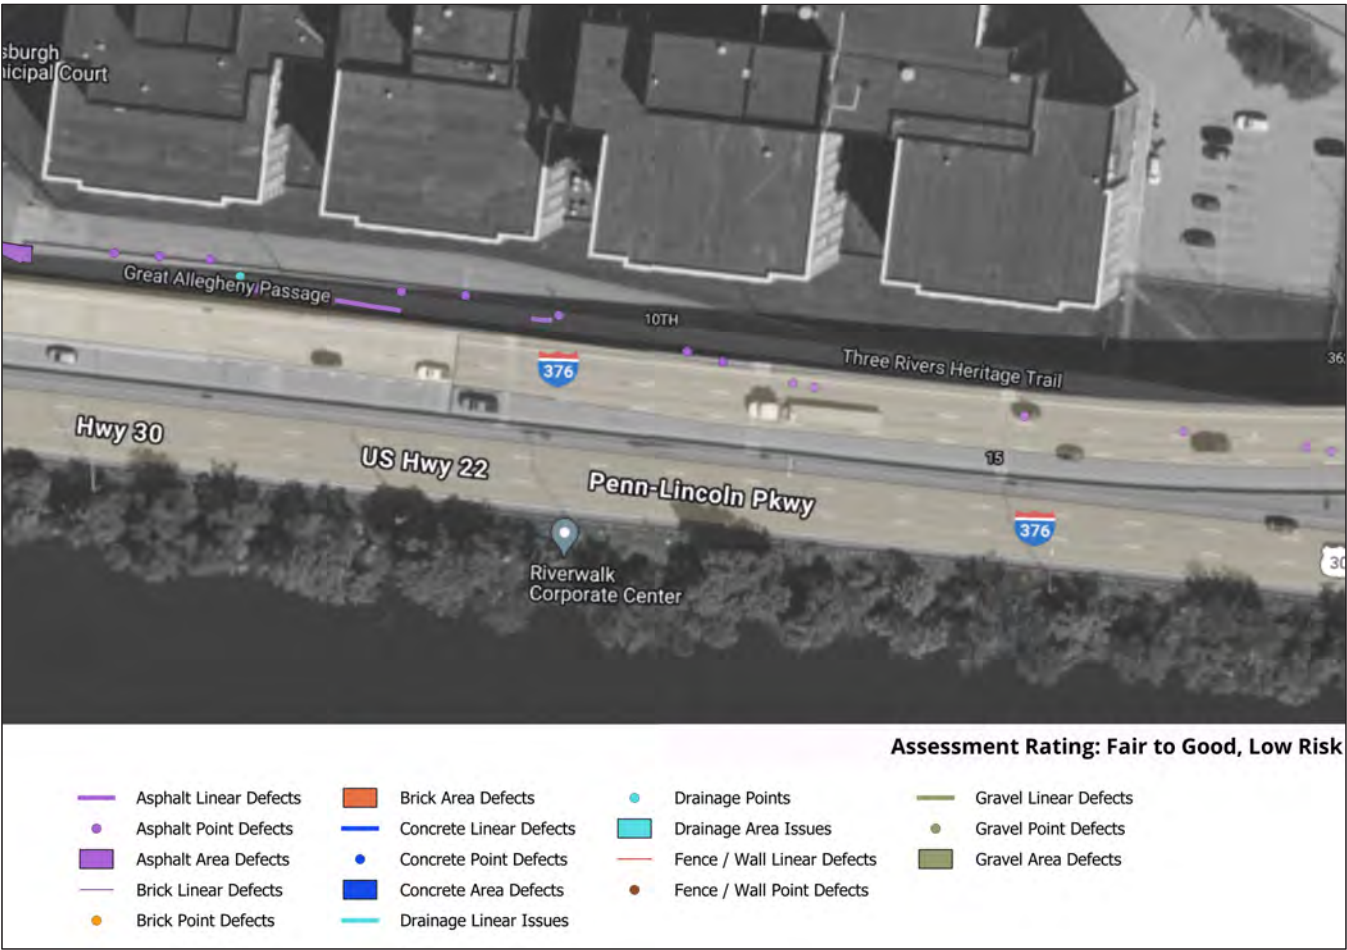
- Heaving by tree roots (marked in red paint).
- Shallow but extensive alligator cracking (~60 sf).
- Numerous transverse/longitudinal cracks, potholes, and depressions. Mostly minor/moderate but frequent, indicating nearing end of service life.

- Aged 2.5 ft timber planter wall. Timbers at risk of falling into travel lane—recommend replacement within a year.
- Another planter wall in better shape, but recommend replacement in 1–3 years.

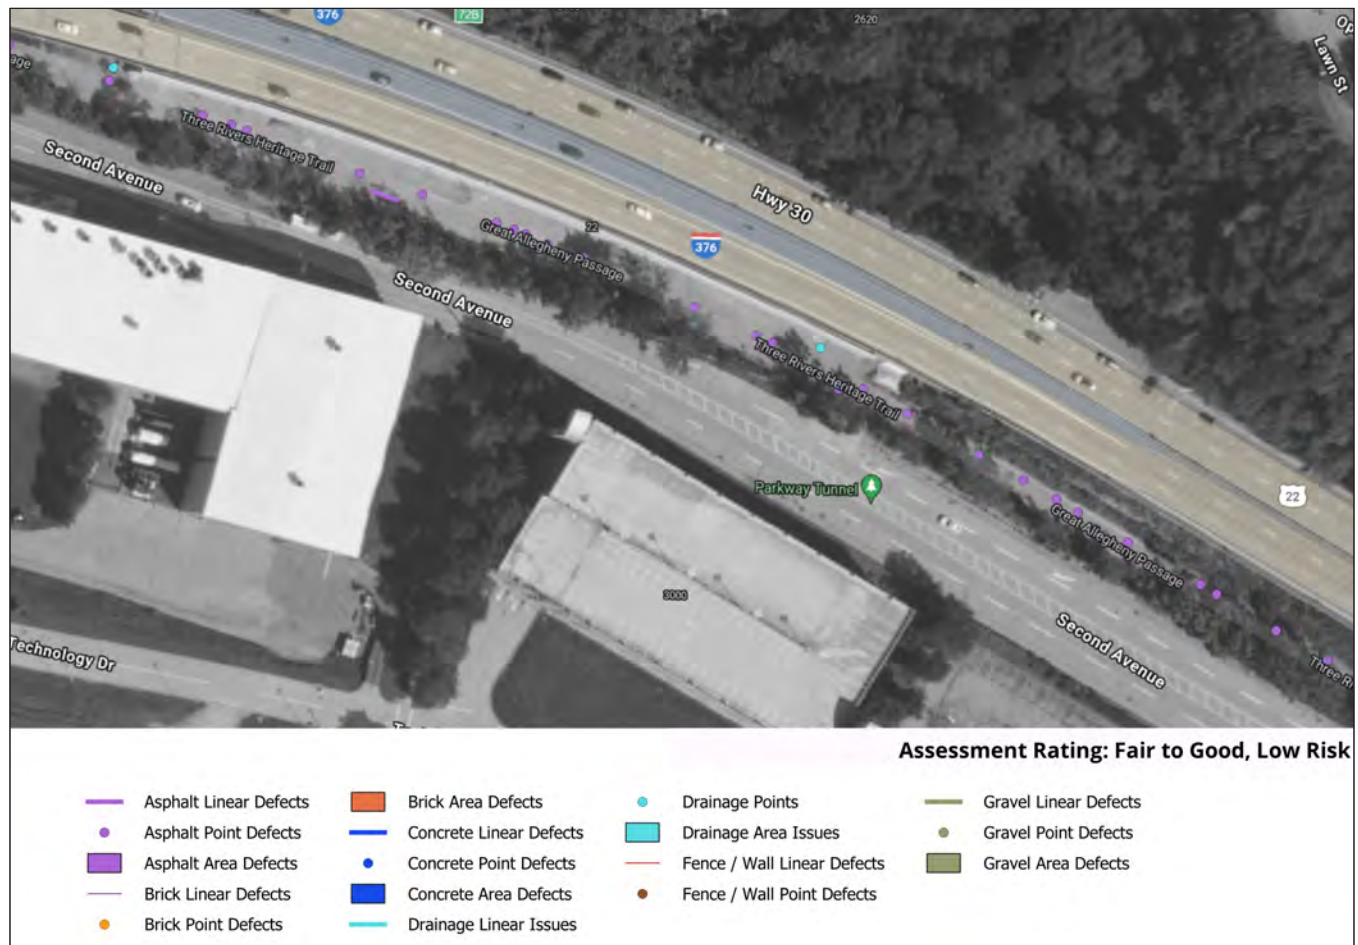
- Numerous transverse, longitudinal, and edge cracks. Mostly minor/moderate, but frequent enough to indicate end of service life.

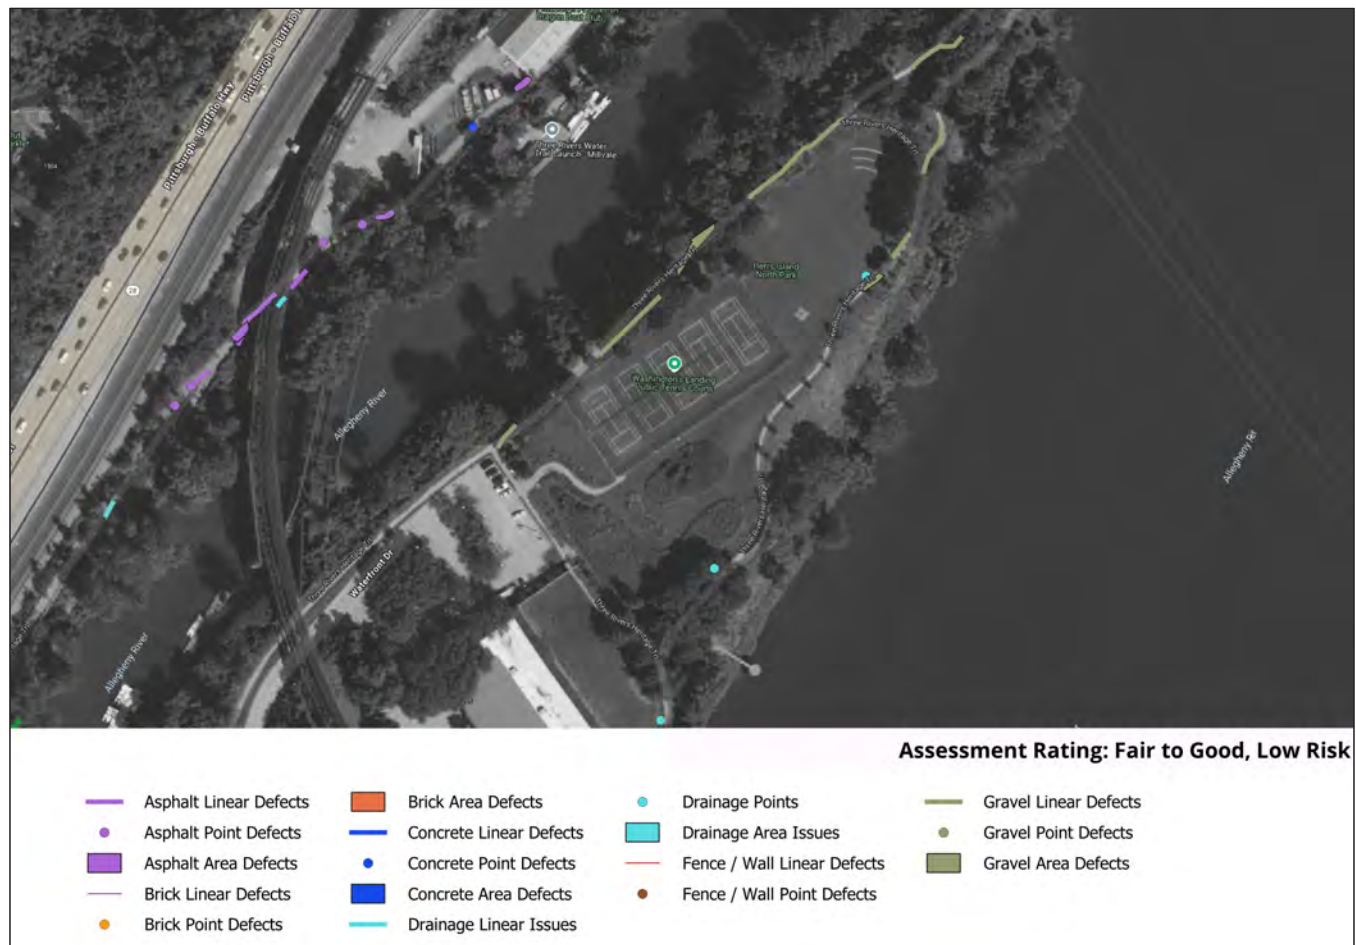
- Several long longitudinal cracks in the pavement surface.

- Tall masonry wall next to steps along trail. Appears privately owned and in good shape aside from possibly loose upper-course blocks.

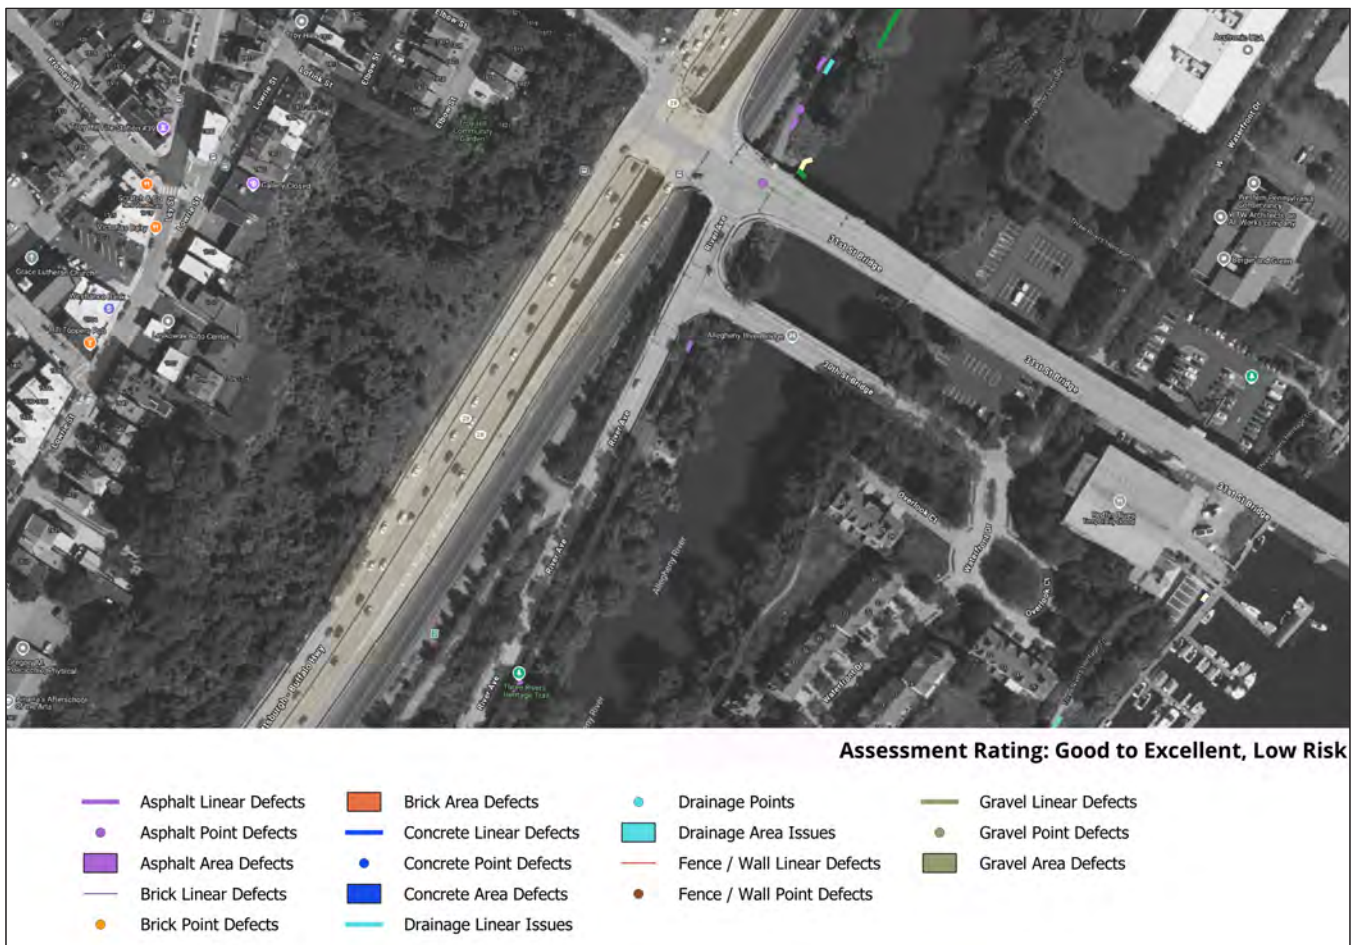
- Concrete barrier prevents water from leaving the trail, causing ponding and siltation (potential long-term issue).
- Minor edge cracking in numerous places.

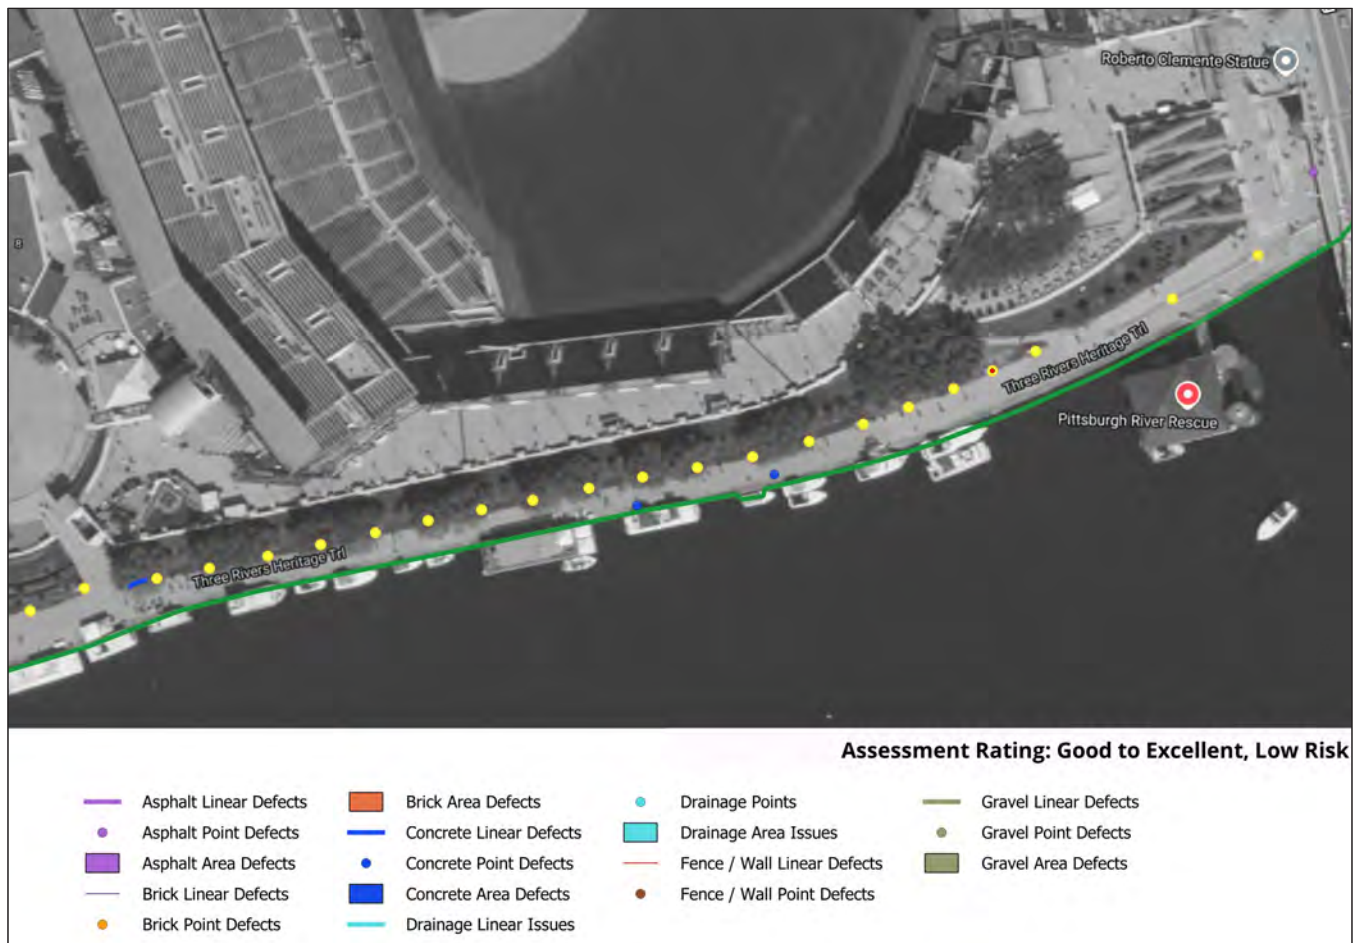
- Sparse minor longitudinal cracks, plus some transverse/corner cracking.

- Concrete river walls along this stretch deemed 'Favorable' to 'Fair' by ACOE. No recommendations at this time.

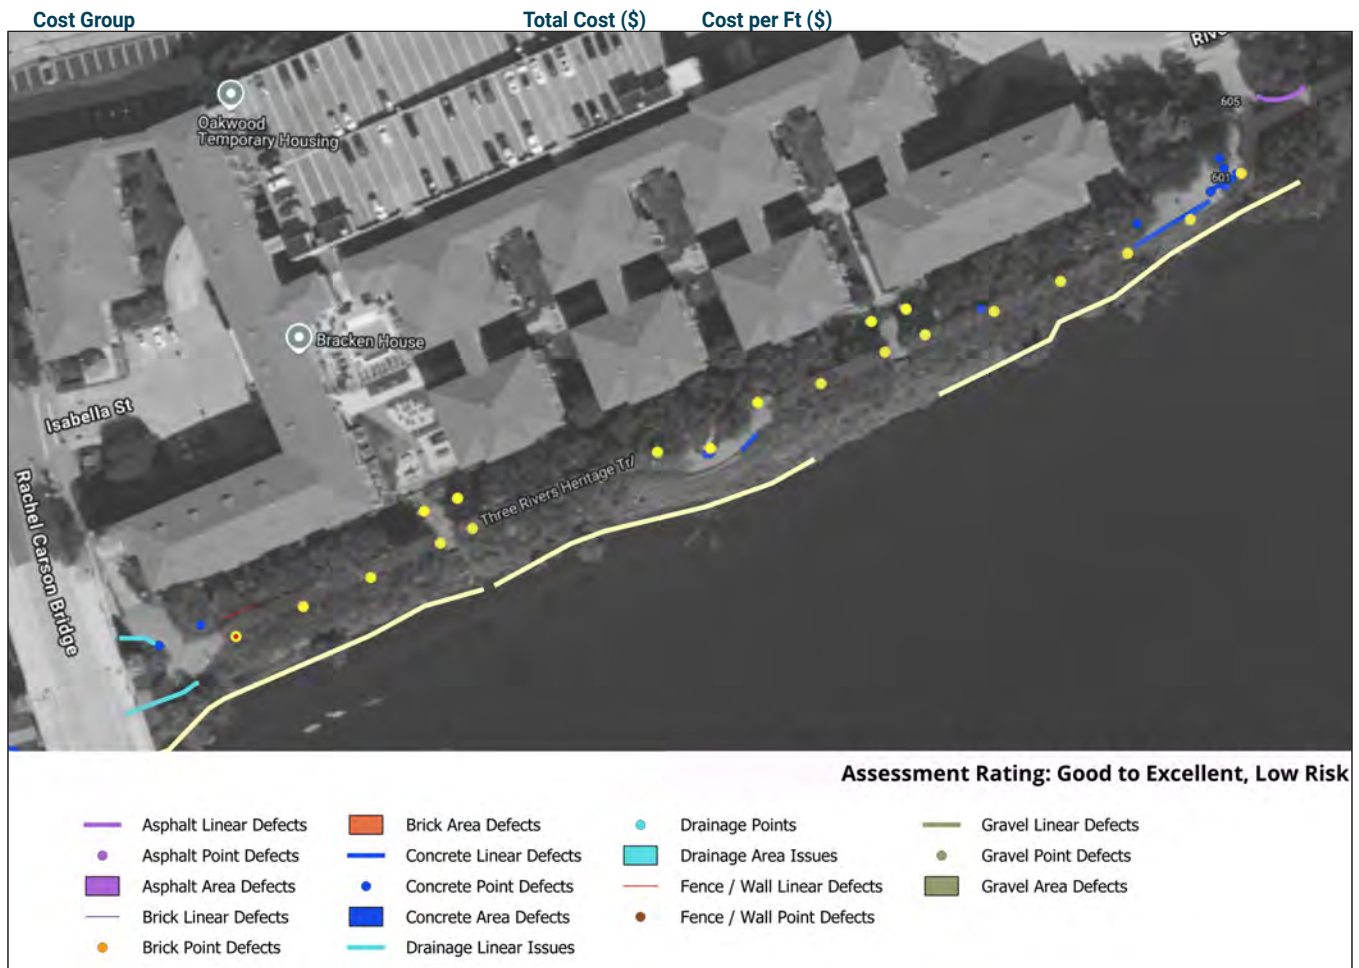
- Low point in the patio with no yard drain.
- Stream bank erosion and some washout under the Rachel Carson Bridge abutment. Slab side is exposed but appears thick.
- Sparse minor longitudinal cracks, plus some transverse/corner cracking.

- Entire stone seat area of the wall apparently knocked loose and replaced without mortar. Recommend full replacement of the top. Wall base is intact and in good shape.

- Light pole is leaning significantly. The seating wall across from it is also damaged.

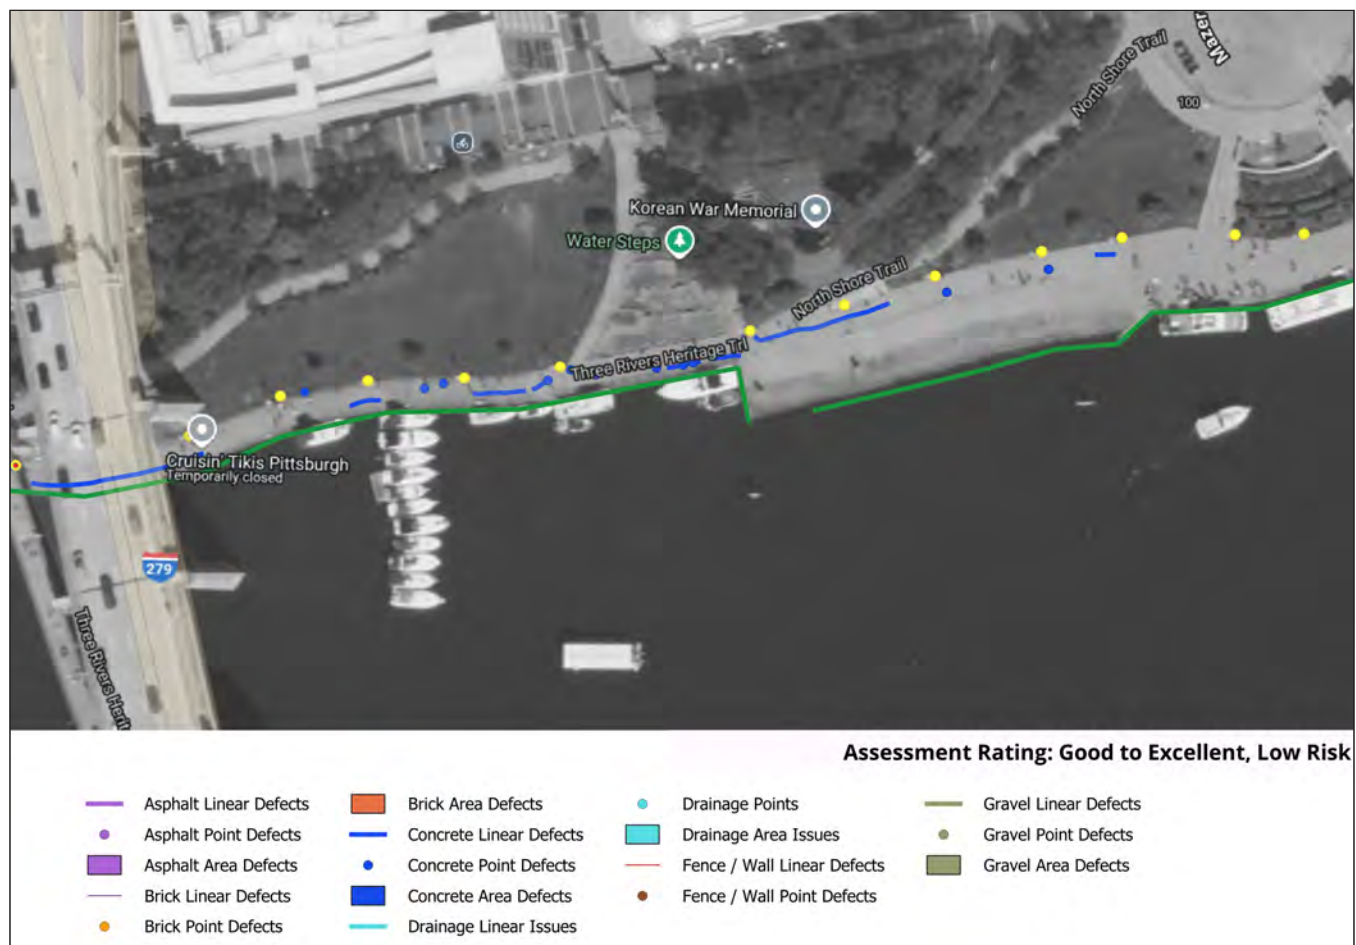
- Numerous minor longitudinal cracks, plus some transverse/corner cracking.

- Concrete river walls along this stretch deemed 'Favorable' to 'Fair' by ACOE. No recommendations at this time.
