# Three Rivers Heritage Trail, Poor to Fair, High Risk

## Summary Report - Trails Surfaces

## SEGMENT: Monongahela North - Section 4, Segment 4

### Trail Surface, Asphalt Paving Assessment and Observations

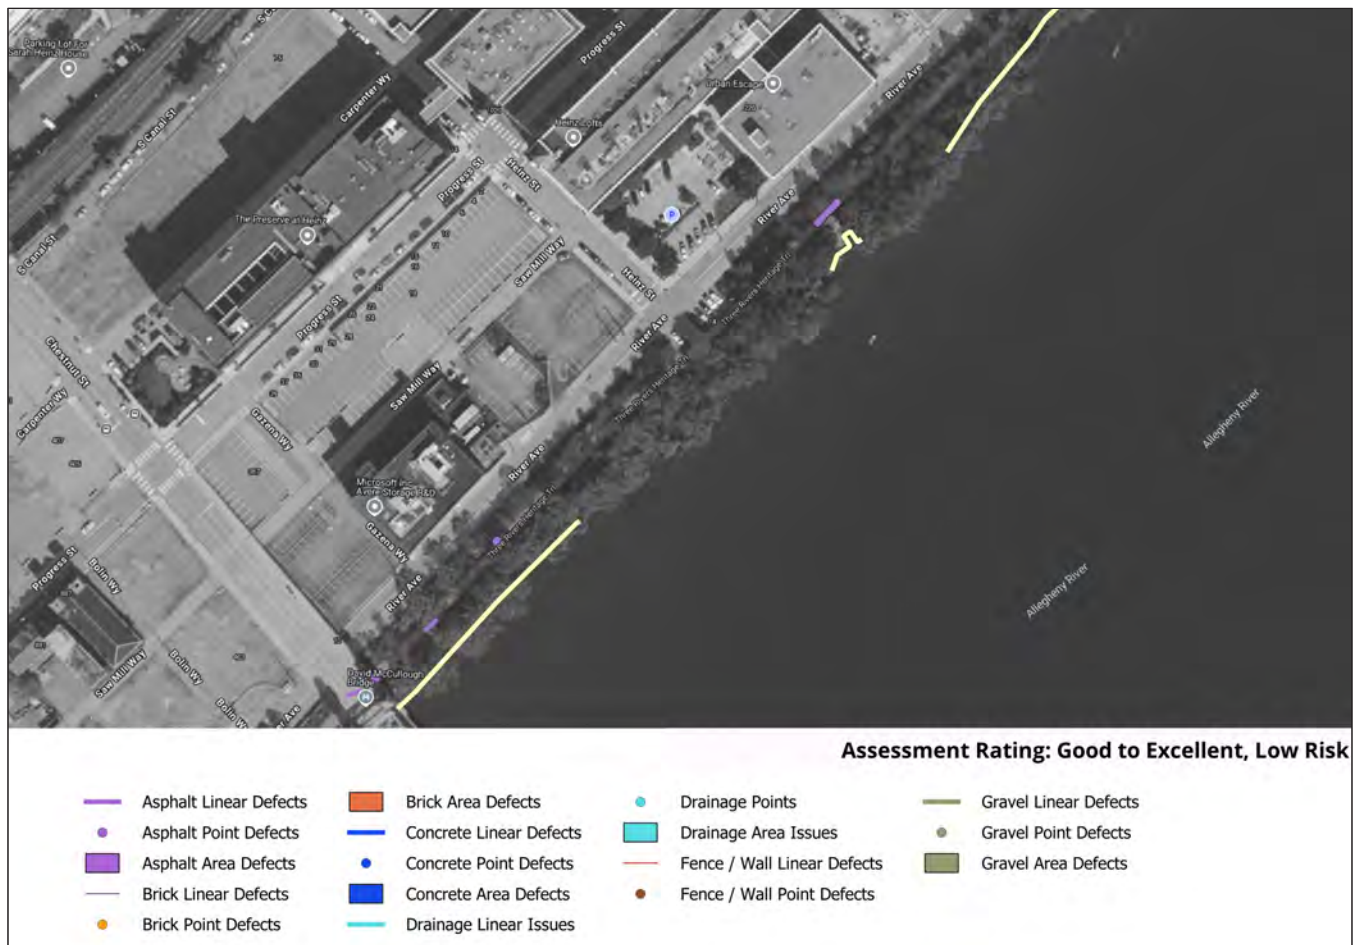
- Patching in good condition (no defects). Suggests former sliding or erosion area. Recommend general monitoring.
- Some minor potholes and transverse cracking.

- Naturalized streambanks/steep slopes within 30 feet of the trail, rated 'Fair' by ACOE/Design Team. One segment of the trail was patched in the vicinity. Recommend reviewing DPW records for details.

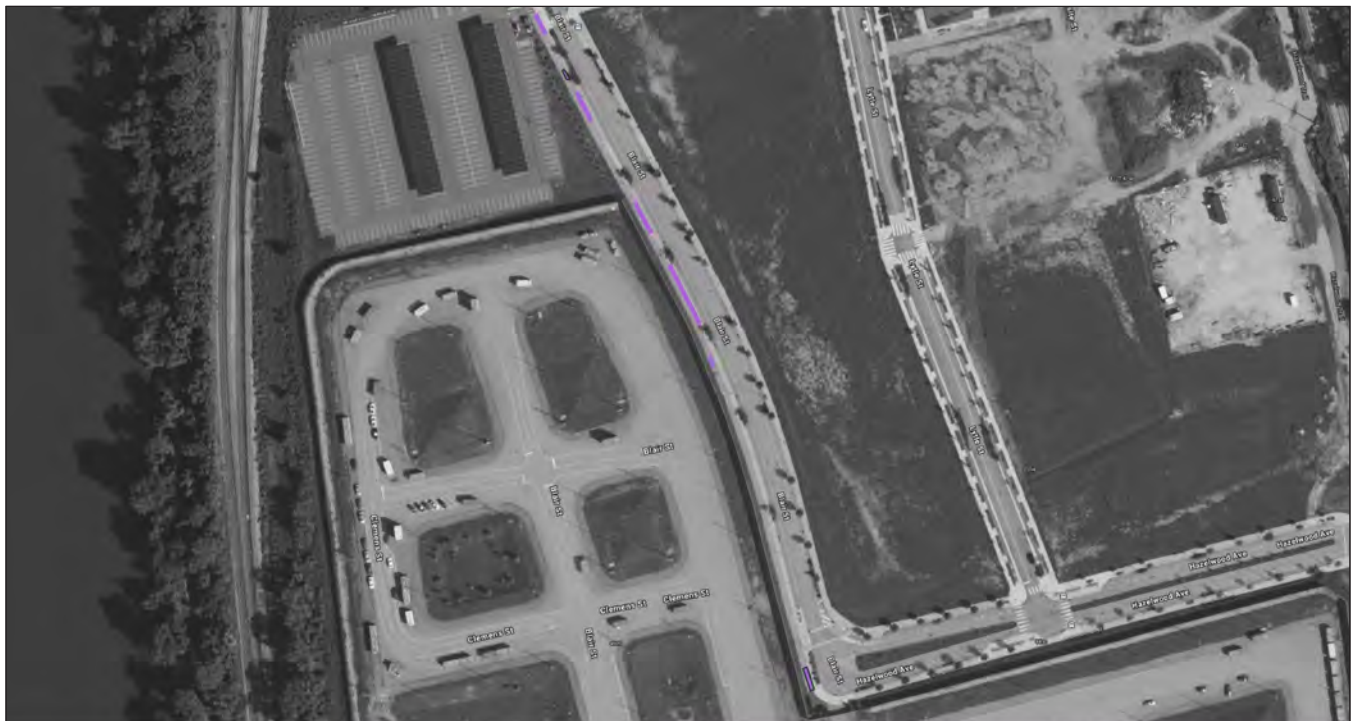
- Fairly large patched section with no apparent cause.
- Gap at interface between asphalt and adjacent pavement (coded as edge cracking). Size roughly that of aggregate. Could allow water intrusion/freeze-thaw damage.

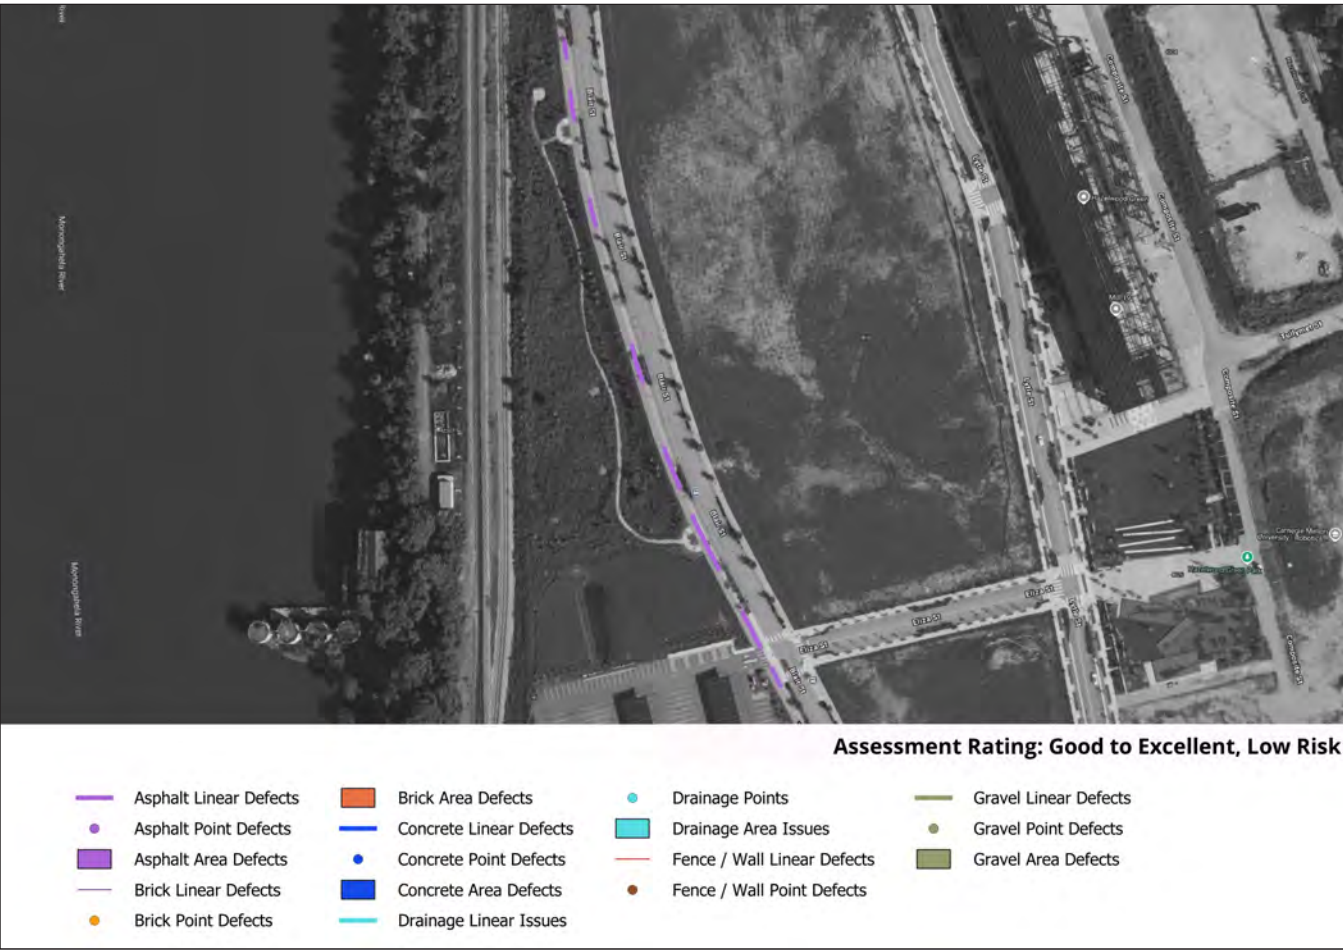
- Gas valve ~1.5 inches below grade, creating small pothole-like depression.
- Gap at asphalt/pavement interface (coded as edge cracking). Could allow water intrusion/freeze-thaw damage.

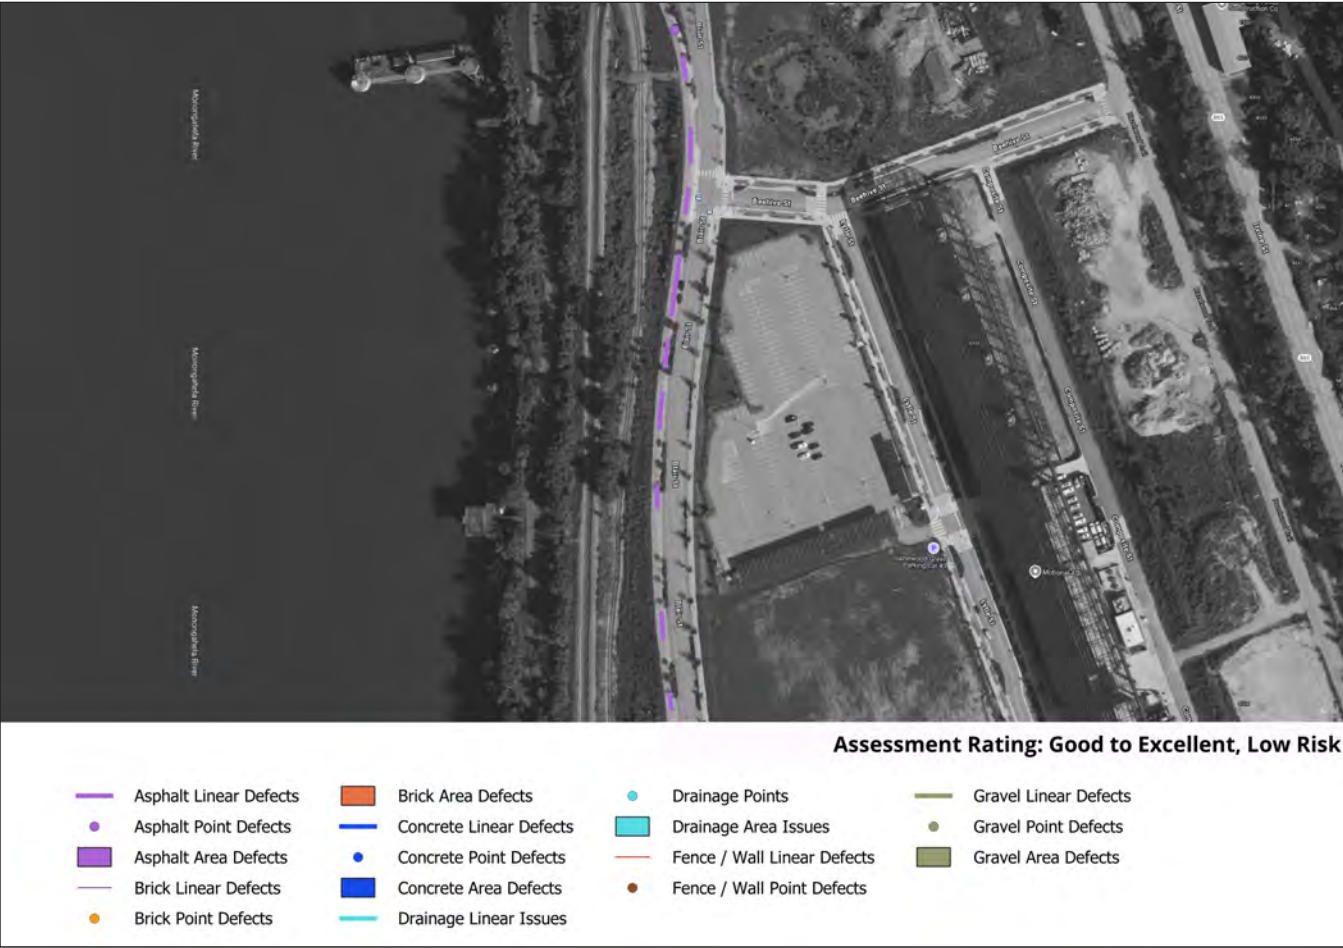
- Raveling of asphalt surface (~10 sf).
- Gap at asphalt/pavement interface (coded as edge cracking). Could allow water intrusion/freeze-thaw damage.

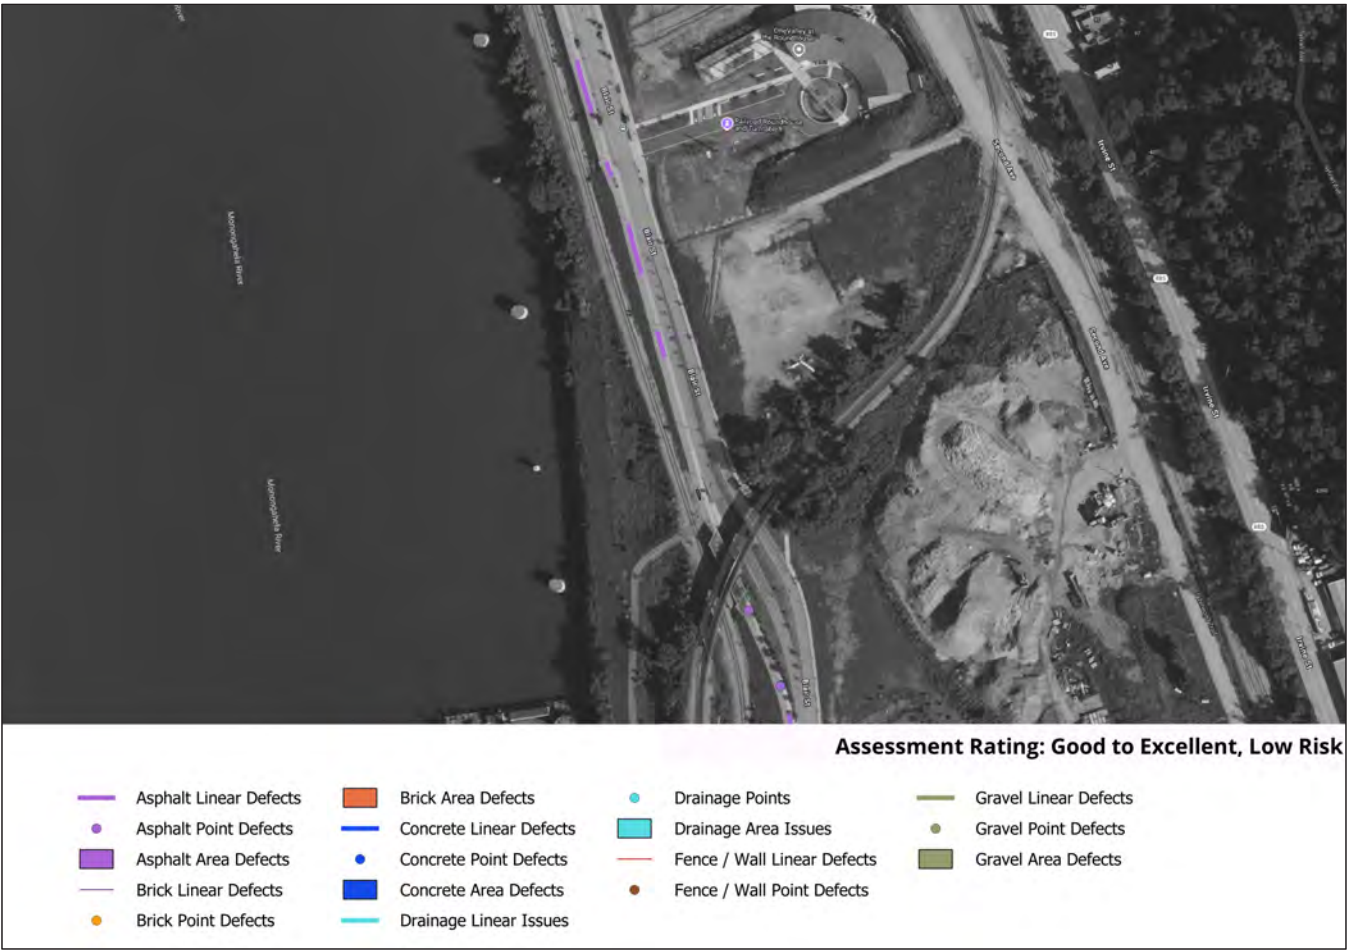
- Gap at asphalt/pavement interface (coded as edge cracking). Could allow water intrusion/freeze-thaw damage.

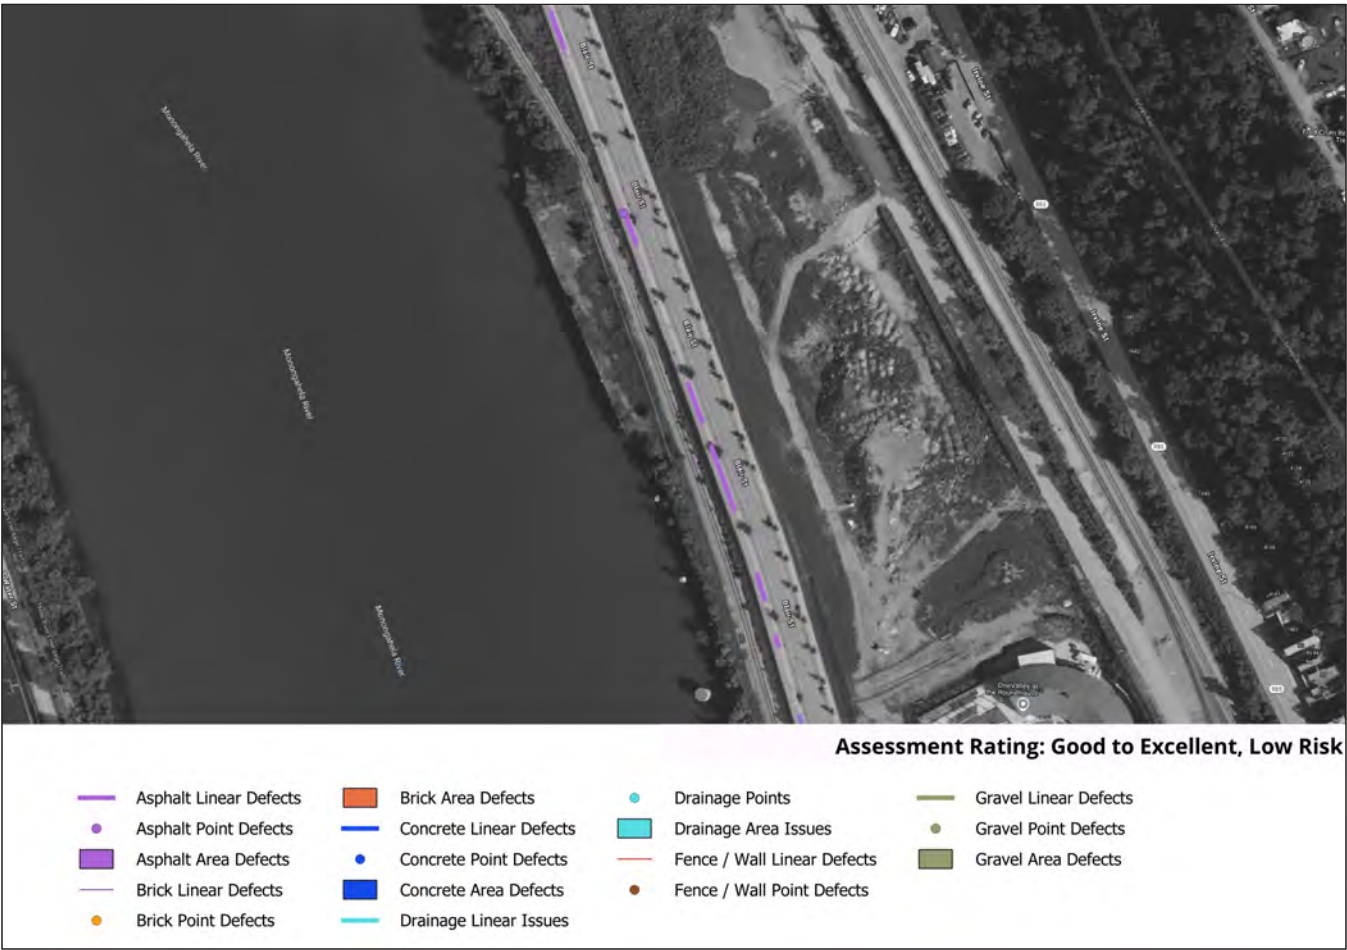
- Gap at asphalt/pavement interface (coded as edge cracking). Could allow water intrusion/freeze-thaw damage.

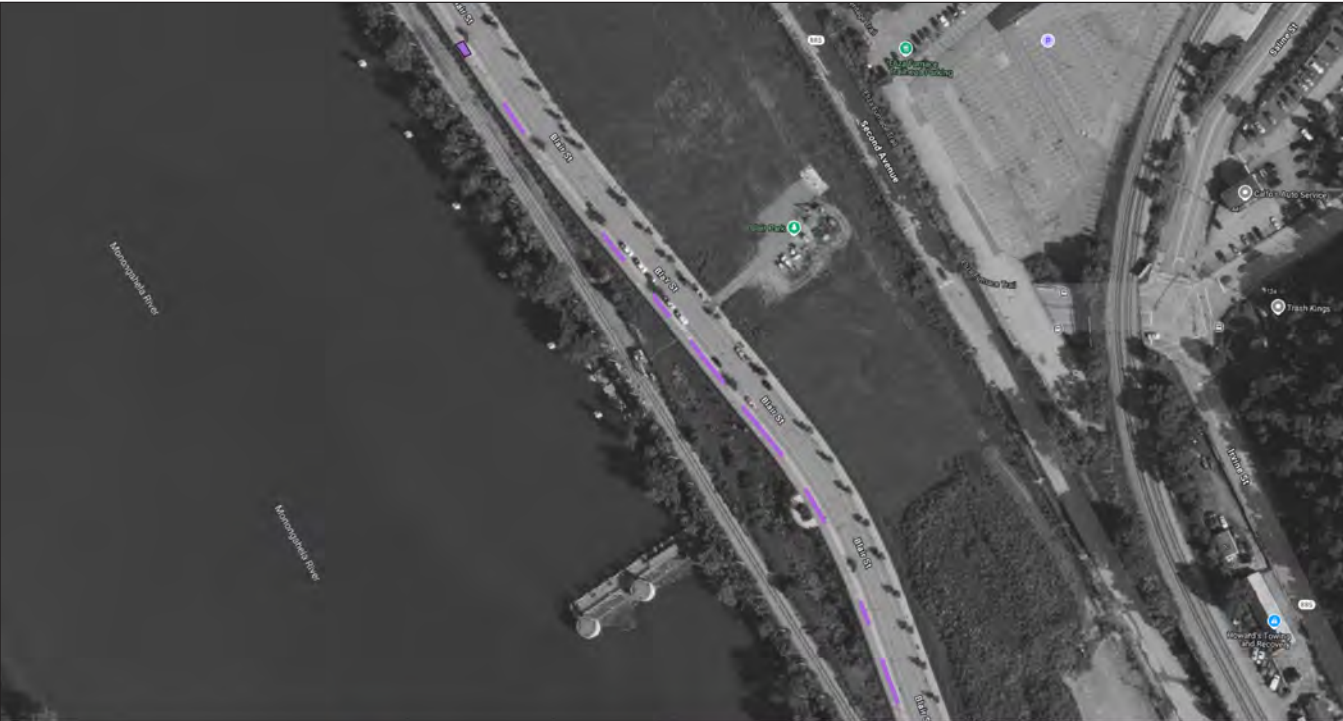
- Raveling (~10 sf).
- Minor raveling over ~20 ft stretch (~35 sf).
- Gap at asphalt/pavement interface (edge cracking). Could allow water intrusion/freeze-thaw damage.

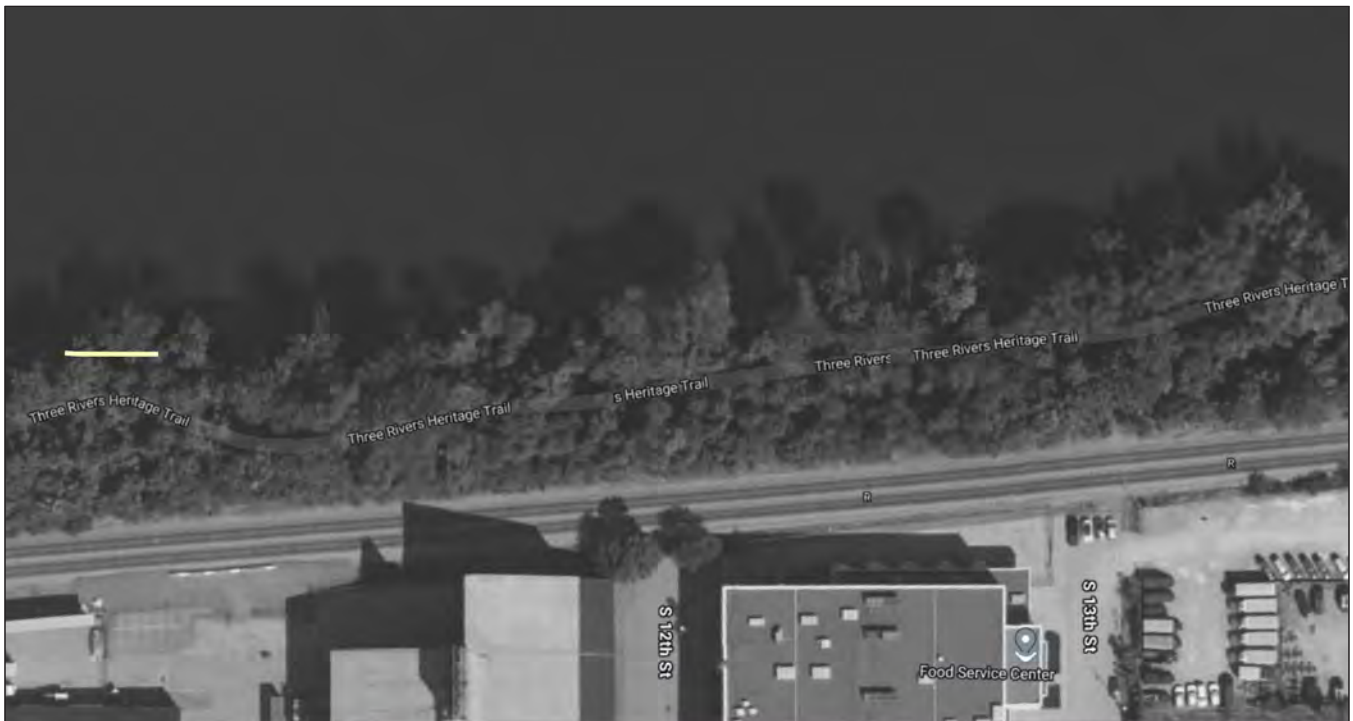
- Heaving/dendritic cracks, likely tree roots.
- Cross-pipe with spalled head wall, some debris clogging. Trail surface remains good.
- Minor edge failure from asphalt poured with insufficient transition on both sides of trail.
- Complete loss of asphalt in places (0–20 inches wide) possibly from excavator activity (trip hazard).
- Moderate edge failure from an overpoured/unreinforced asphalt layer.
- Extensive spray painting on surface, beyond Color Park limits.

- Chain-link fence breaches (top rails missing, bottom rail/mesh damaged), possibly intentional or from fallen trees.
- Another large hole intentionally cut in newly installed fence.
