# MANCHESTER HISTORIC DISTRICT DESIGN GUIDELINES

September 2026

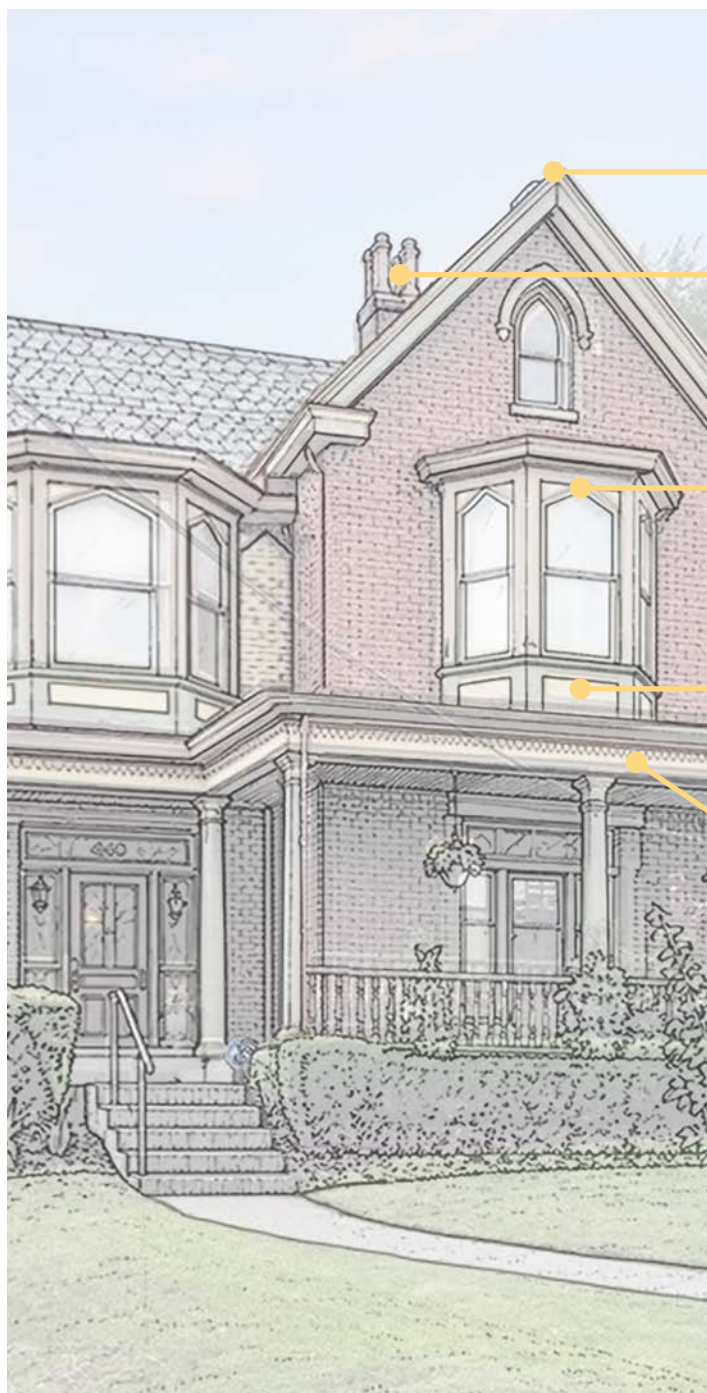
**KEY DEFINING FEATURES OF THE GOTHIC REVIVAL STYLE**

*steeply-pitched roof*

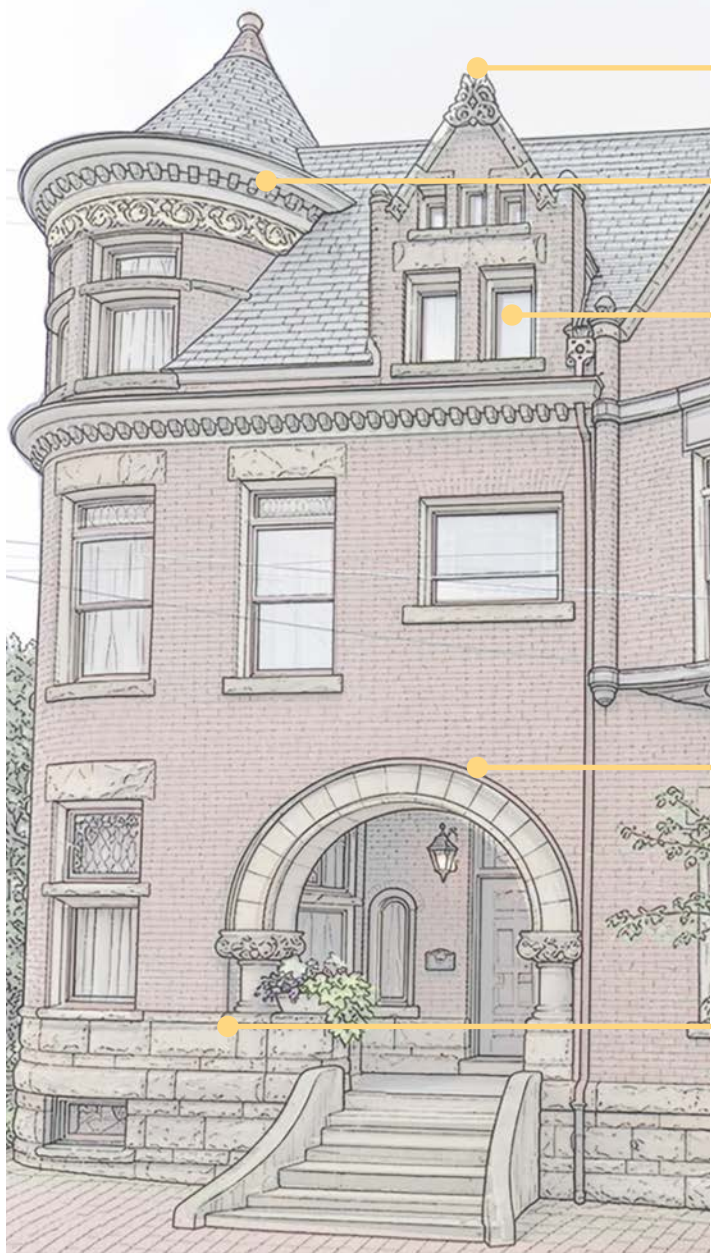
**KEY DEFINING FEATURES OF THE ROMANESQUE REVIVAL STYLE**

*masonry dormer*

*stone foundation and/or walls and trim*

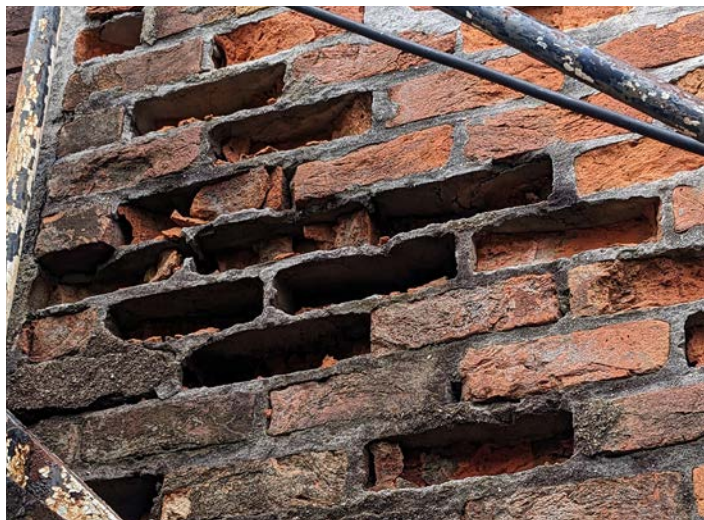
*Example of deterioration to masonry caused by inappropriate strength mortar repair.*

- 2.1.10** Portland cement **mortar** is too high in strength for historic masonry and likely to cause damage during freeze-thaw cycles. A typical compatible mortar is Type N or S, using a combination of Portland cement, lime, and sand.

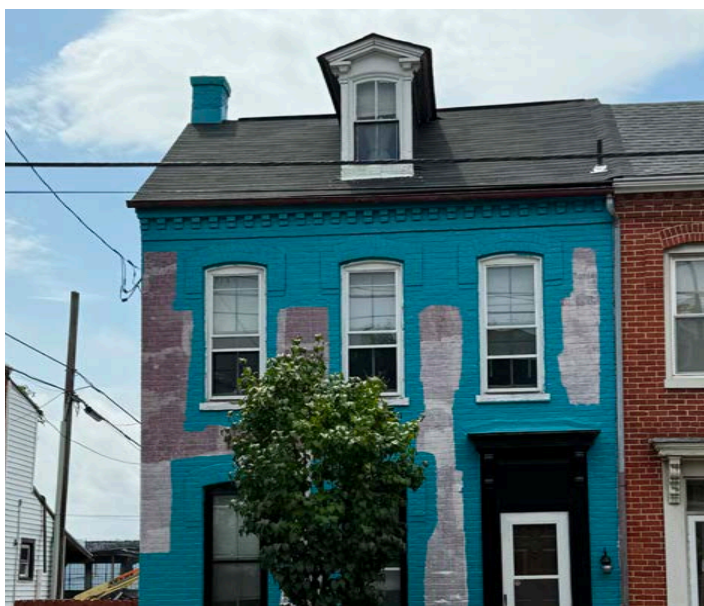
*Example of inappropriate use of paint on masonry substrates.*

- 2.1.3 Stone or brick** also should not be painted or treated with water-repellent coatings. These coatings can trap moisture and cause deterioration of masonry walls.

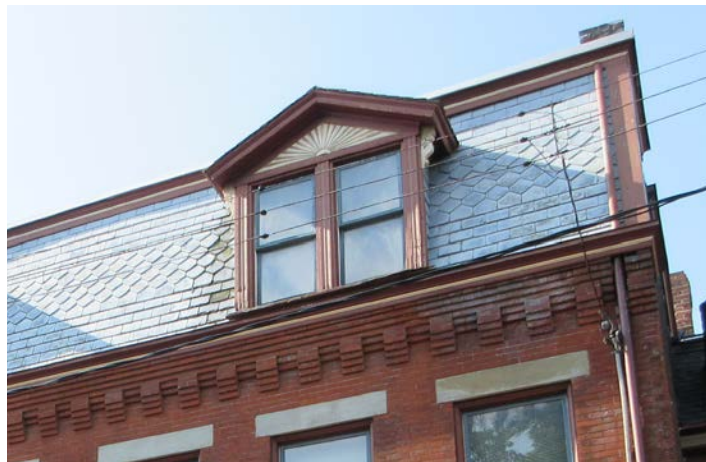
*Historic slate roofing*

**2.2.1 Repair and restore** original roofing whenever possible. Before replacing historic roof materials such as slate or terra cotta, evaluate whether repair or localized areas of in-kind replacement of shingles or tiles is feasible.

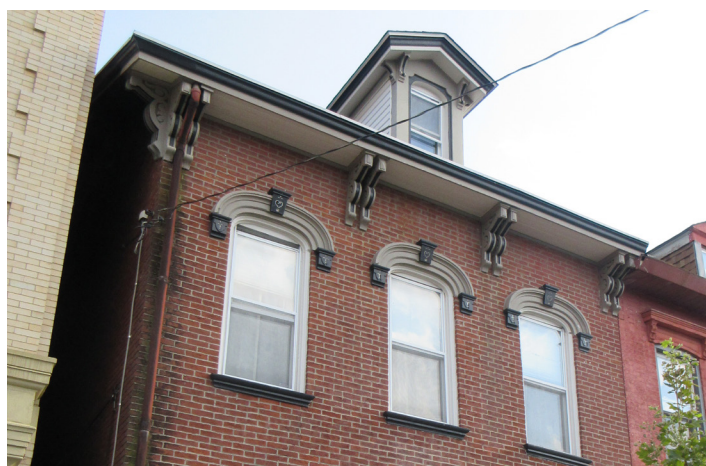
*Historic built in gutters and metal downspouts.*

- 2.2.10** Maintain built-in (box) **gutters** and/or repair them in kind. Hung “K-style” gutters are not appropriate on historic buildings in the Manchester Historic District.

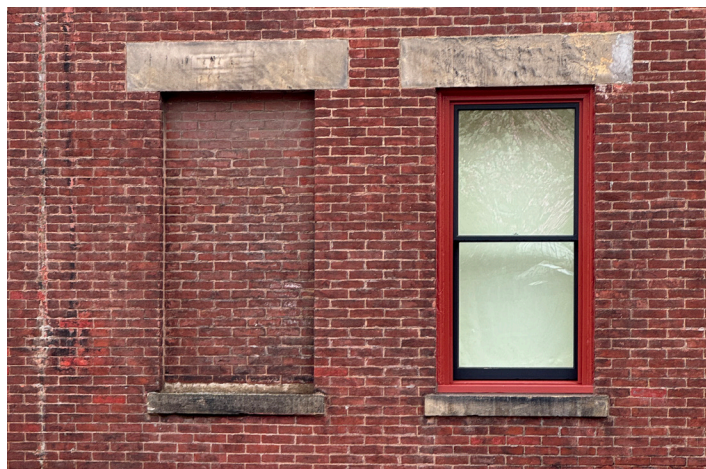
*Example of appropriate window infill on a non-primary facade.*

**2.4.14** The introduction of **new window openings or alteration or infill of existing openings** are not appropriate on primary facades. If creating new openings or infilling existing openings is necessary to accommodate new interior uses, locate openings on secondary or non-contributing facades.

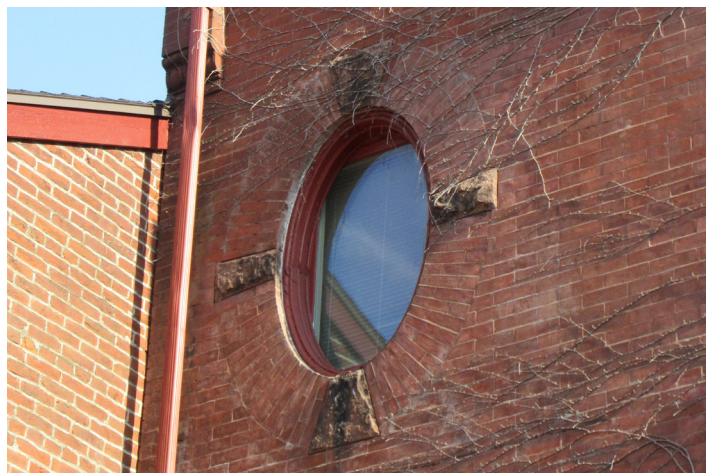
*Example of replacement window that is not appropriate (square window in a round opening).*

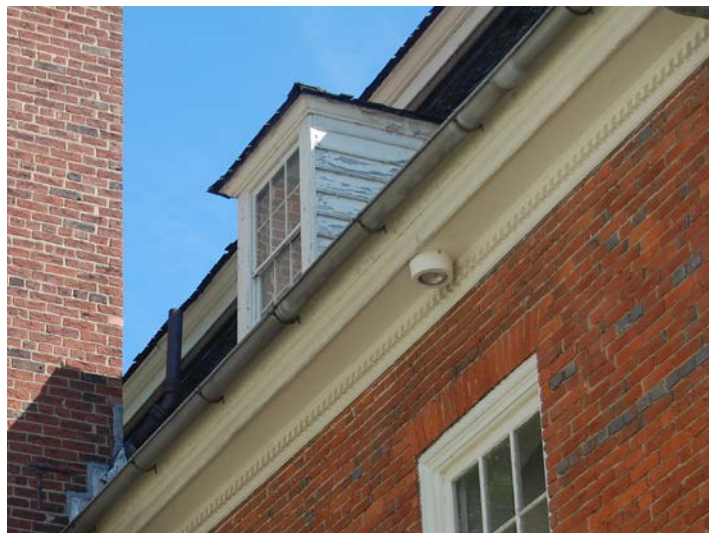
*Modern facade lighting is concealed under the eave and the fixture color blends in; this is an appropriate installation.*

- 3.5.6** Facade lighting was not historically present on most buildings in the Manchester Historic District. When introducing light fixtures to primary and secondary facades, **select for appropriate size, scale, materials** (usually a combination of metal and glass), **and design**, and locate fixtures so as not to damage or obscure historic materials and architectural features.

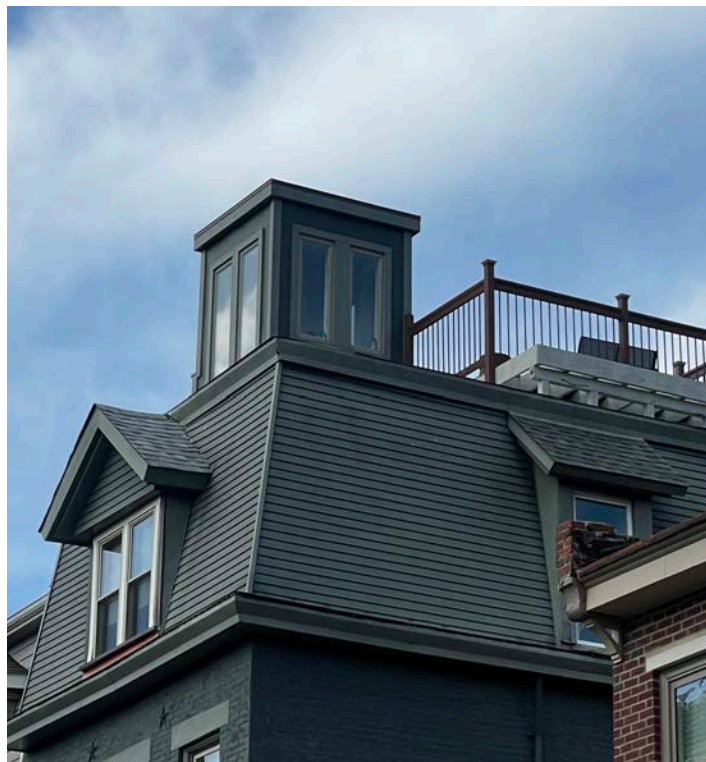
*Example of inappropriate addition in massing, scale and location.*

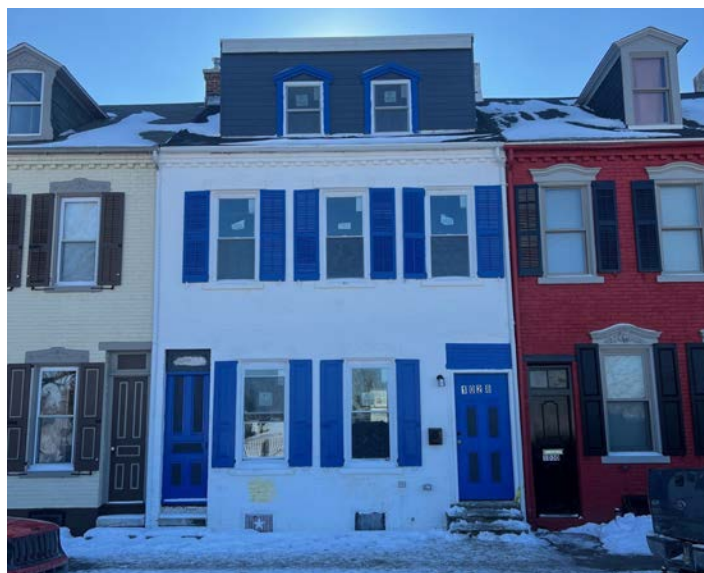
*Example of an inappropriate dormer addition, which removed an original dormer and introduced non-historic proportions.*
