# MEXICAN WAR STREETS HISTORIC DISTRICT

## DESIGN GUIDELINES

Sept 2026

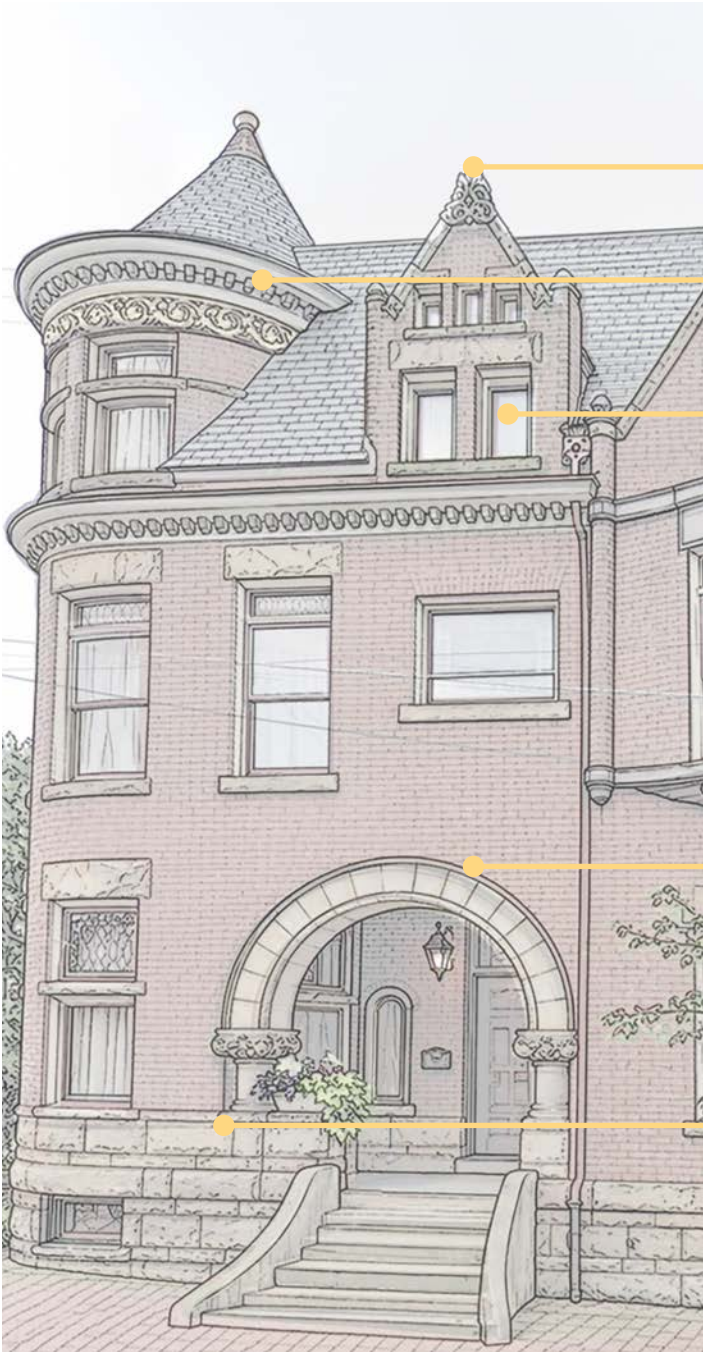
KEY DEFINING FEATURES OF THE ROMANESQUE REVIVAL STYLE

- hip roofed dormer
- tower with conical roof
- deeply recessed windows and doors
- round arch
- stone foundation and/or walls and trim

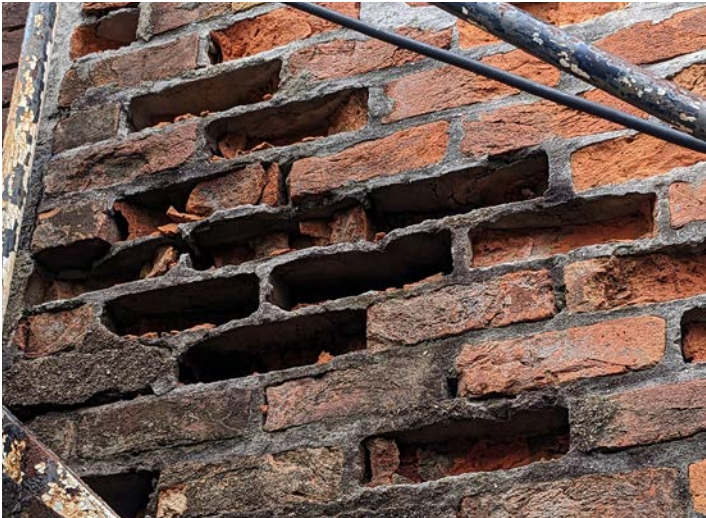
Example of deterioration to masonry caused by inappropriate strength mortar repair.

- 2.1.10 Portland cement **mortar** is too high in strength for historic masonry and likely to cause damage during freeze-thaw cycles. A typical compatible mortar is Type N or S, using a combination of Portland cement, lime, and sand.

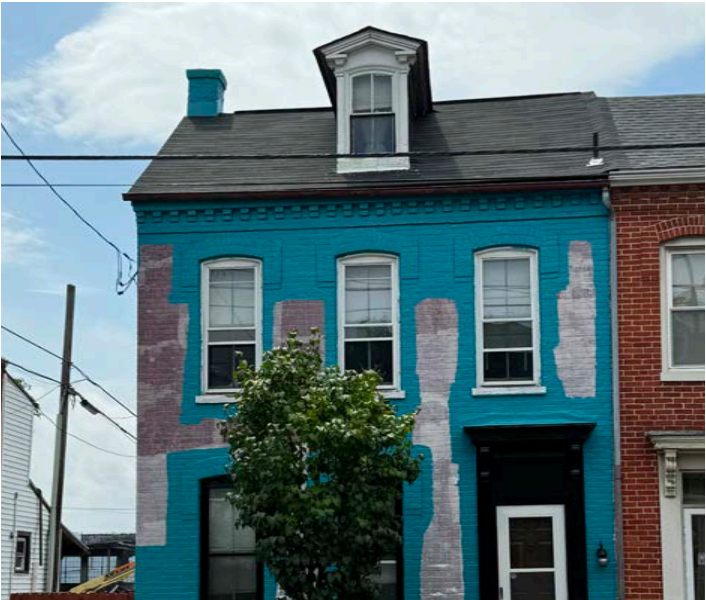
Example of inappropriate use of paint on masonry substrates.

- 2.1.3 Stone or brick also **should not be painted** or treated with water-repellent coatings. These coatings can trap moisture and cause deterioration of masonry walls.

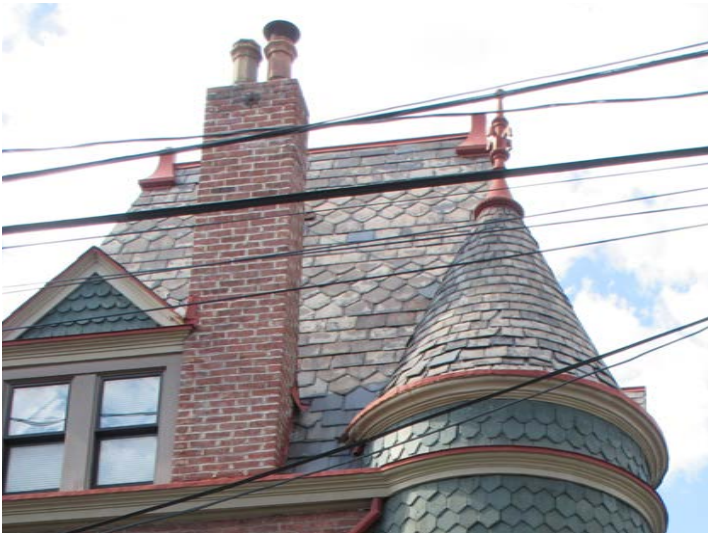
Historic slate roofing

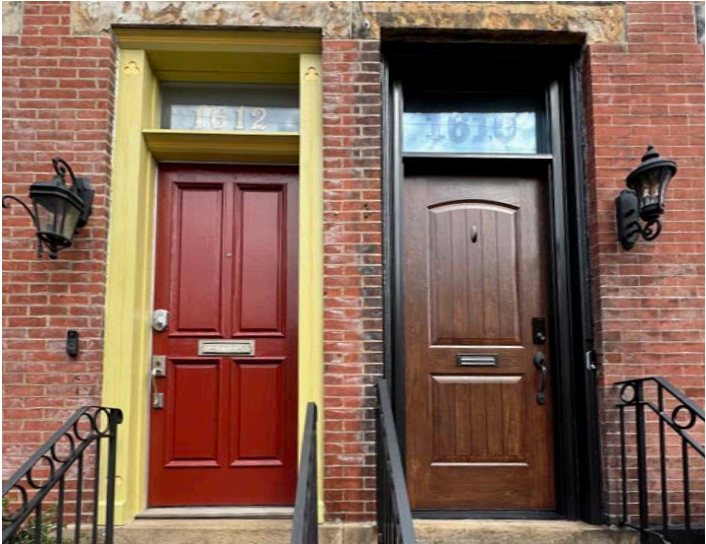
Appropriate replacement door (on right) is in keeping with the character of historic doors.

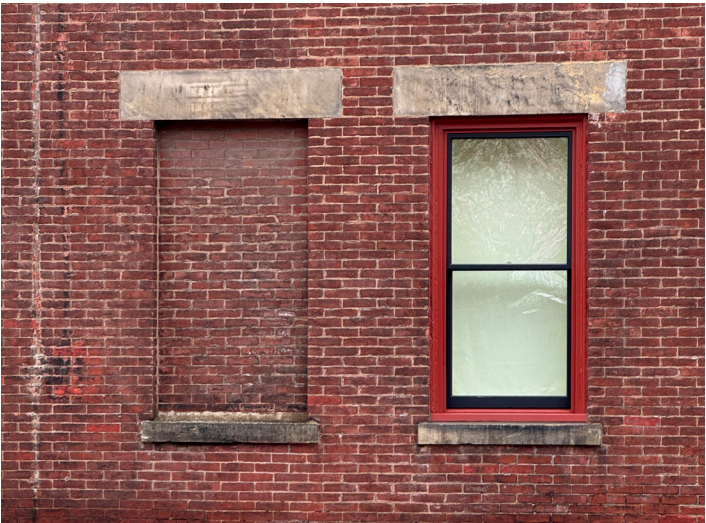
Example of appropriate window infill on a non-primary facade.

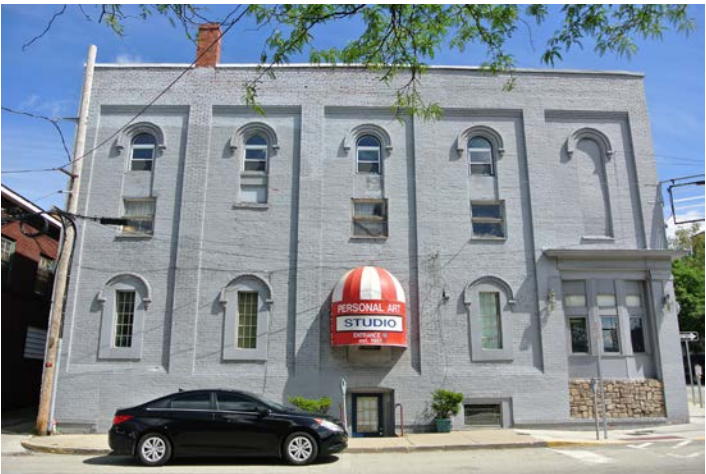
Example of replacement windows that are not appropriate.

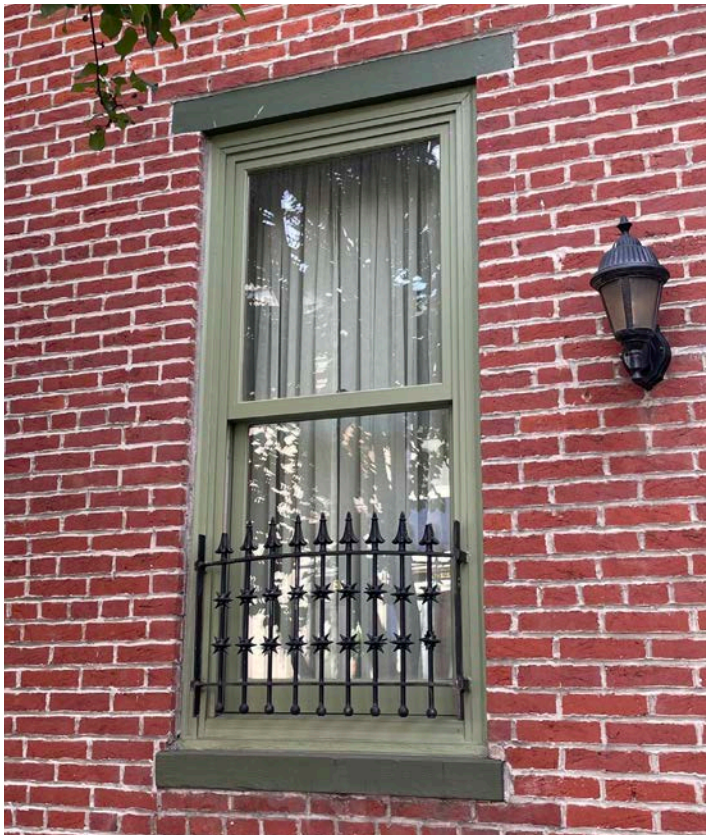
Example of appropriate window grill design and configuration.

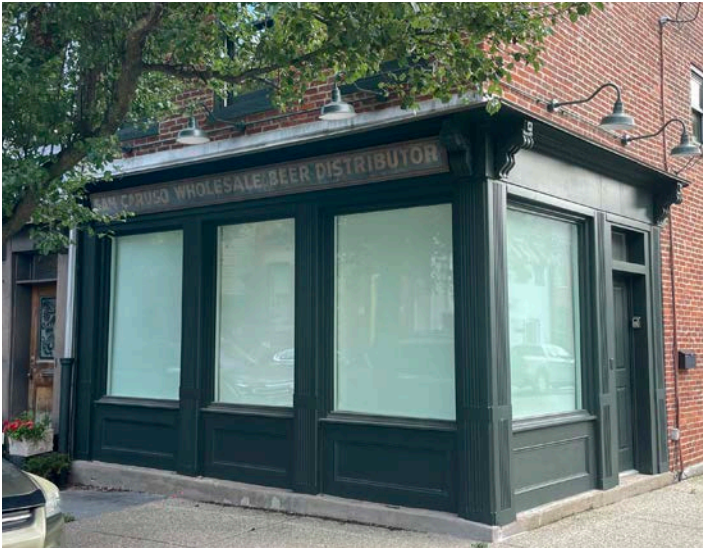
Historic storefront with wood panels, detailing, and signboard.

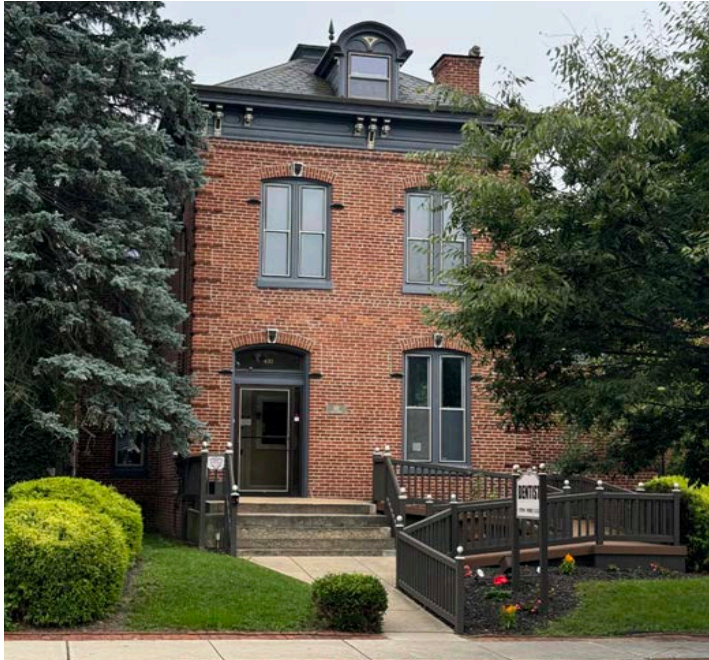
Example of an appropriate accessible entry modification.

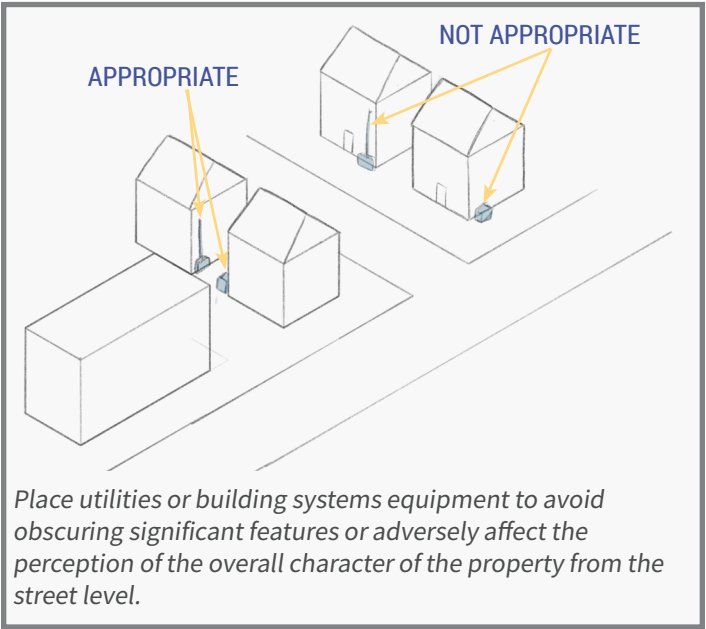
Appropriate example of a meter and vents placed on secondary facade.

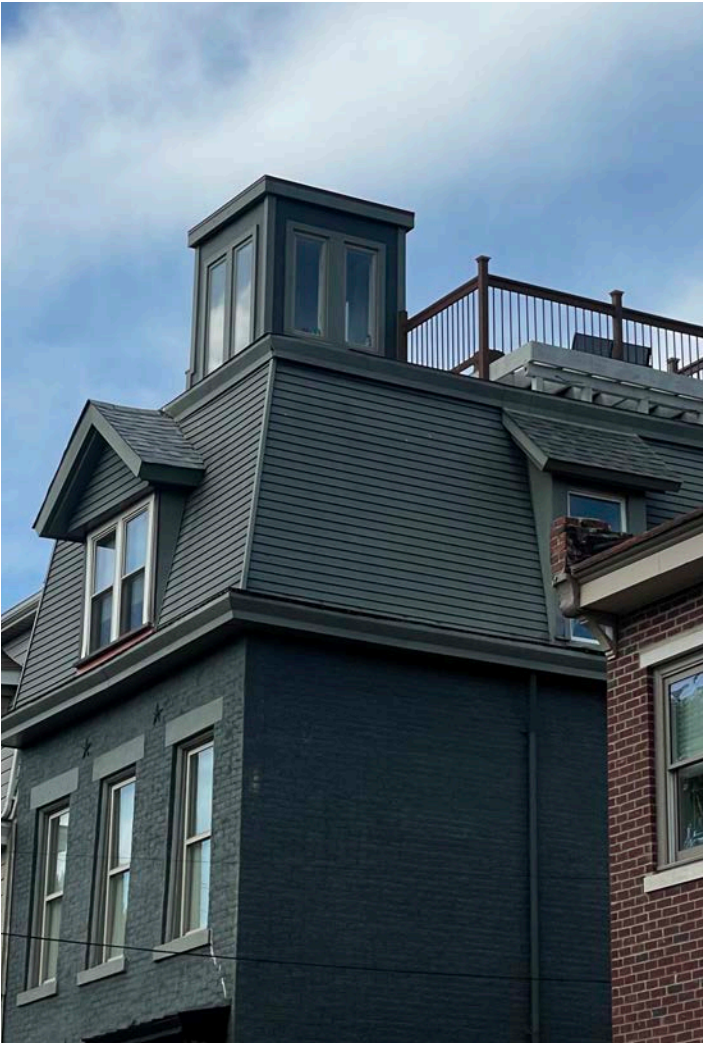
Example of additions inappropriate in massing, scale and location.

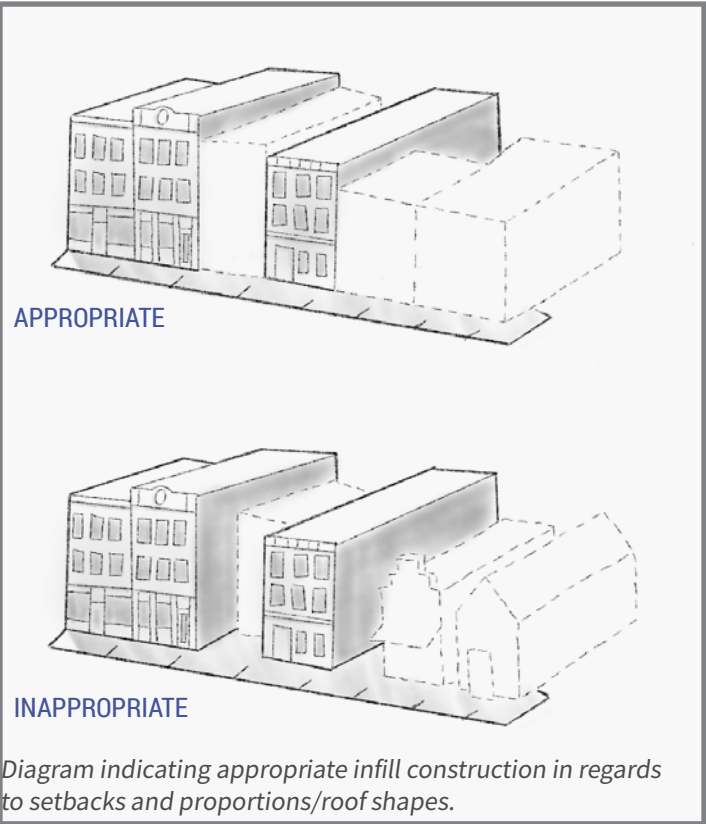
Diagram indicating appropriate infill construction in regards to setbacks and proportions/roof shapes.

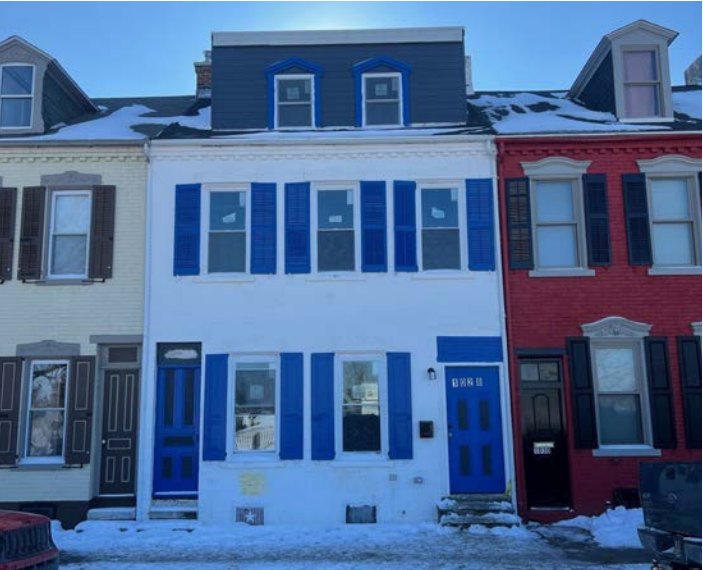
Example of an inappropriate dormer addition, which removed an original dormer and created non-historic proportions.
